Failure of an Automobile Rear Axle

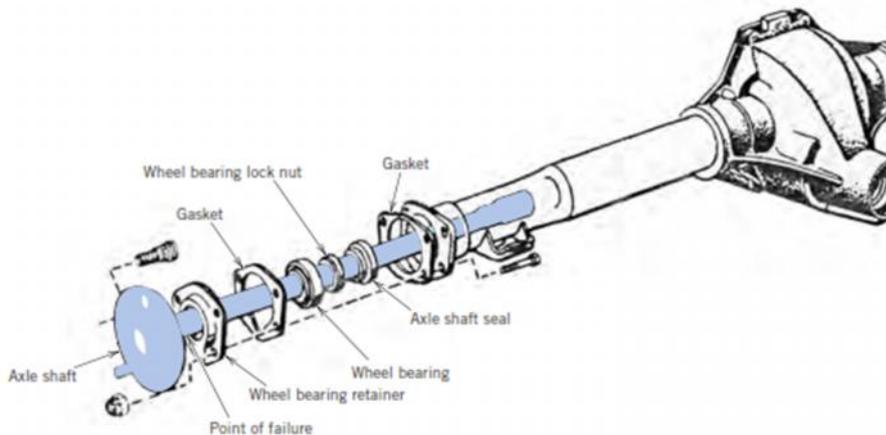
Figure 22.11 is a schematic diagram that shows the components of a rear axle assembly of the type used in this pickup truck. The fracture occurred adjacent to the bearing lock nut, as noted in this schematic.

Figure 22.11 Schematic diagram showing typical components of a light truck axle, and the fracture site for the failed axle of this case study. (Reproduced from *MOTOR Auto Repair Manual*, 39th Edition © Copyright 1975. By permission of the Hearst Corporation.)

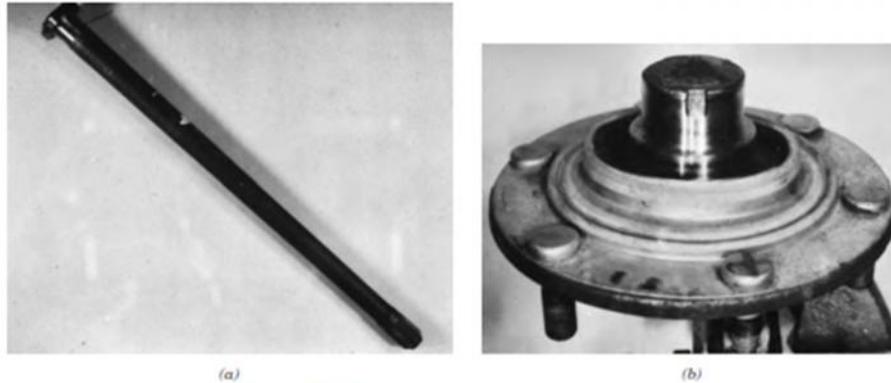
Upon examination of the fracture surface it was noted that the region corresponding to the outside shaft perimeter [being approximately 6.4 mm (0.25 in.) wide] was very flat; furthermore, the center region was rough in appearance.

Figure 22.12 (a) Photograph of one section of the failed axle. (b) Photograph showing wheel mounting flange and stub end of failed axle. [Reproduced with permission from *Handbook of Case Studies in Failure Analysis, Vol. 1* (1992), ASM International, Materials Park, OH, 44073-0002.]

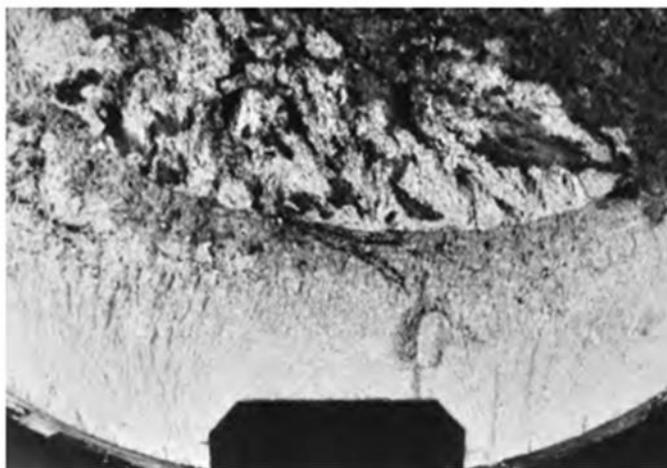
Details of the fracture surface in the vicinity of the keyway are shown in the photograph of Figure 22.13; note that the keyway appears at the bottom of the photograph. Both the flat outer perimeter and rough interior regions may be observed in the photograph. There are **chevron patterns** that emanate inward from the corners of and parallel to the sides of the keyway; these are barely discernible in the photograph, but indicate the direction of crack propagation. Fractographic analyses were also conducted on the fracture surface. Figure 22.14 shows a scanning electron micrograph taken near one of the keyway corners. Cleavage features may be noted in this micrograph, whereas any evidence of dimples

Figure 22.13 Optical micrograph of failed section of axle that shows the keyway (bottom), as well as the flat outer perimeter and rough core regions. [Reproduced with permission from *Handbook of Case Studies in Failure Analysis, Vol. 1* (1992), ASM International, Materials Park, OH, 44073-0002.]

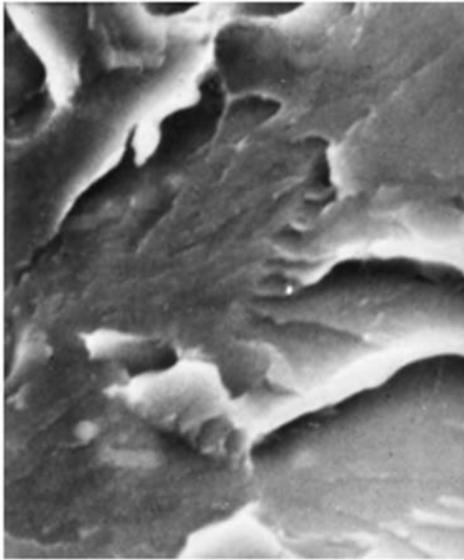
Figure 22.14 Scanning electron micrograph of failed axle outer perimeter region near the keyway, which shows cleavage features. 3500 \times . [Reproduced with permission from *Handbook of Case Studies in Failure Analysis, Vol. 1* (1992), ASM International, Materials Park, OH, 44073-0002.]

and fatigue striations is absent. These results indicate that the mode of fracture within this **outer periphery** of the shaft was **brittle**.

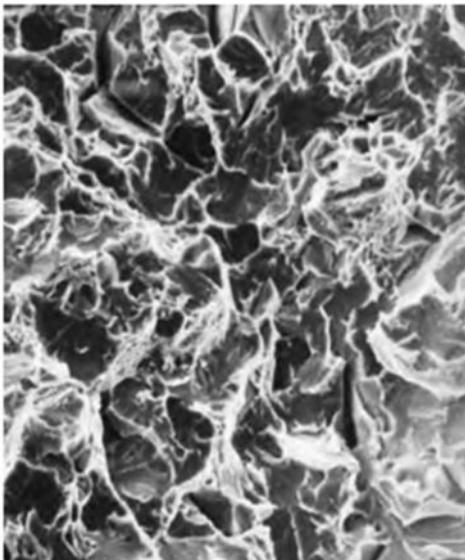
An SEM micrograph taken of **the rough central region** (Figure 22.15) revealed the presence of both **brittle cleavage features and also dimples**; thus, it is apparent that the failure mode in this central interior region was mixed; that is, it was a **combination of both brittle and ductile fracture**.

Figure 22.15 Scanning electron micrograph of the failed axle rough central core region, which is composed of mixed cleavage and dimpled regions. 570 \times . [Reproduced with permission from *Handbook of Case Studies in Failure Analysis, Vol. 1* (1992), ASM International, Materials Park, OH, 44073-0002.]

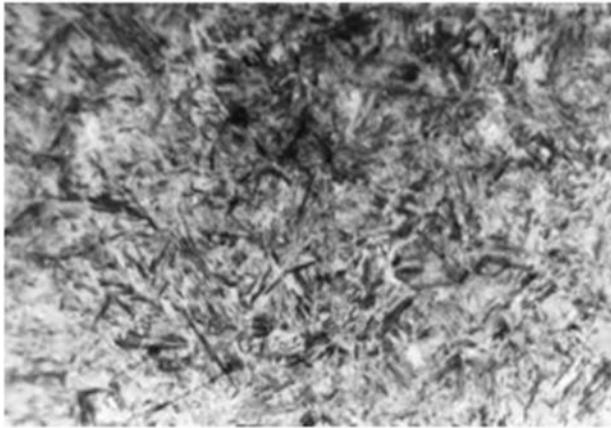
Metallographic examinations were also performed. A transverse cross section of the failed axle was polished, etched, and photographed using the **optical microscope**. The microstructure of the outer periphery region, as on the other hand, in the central region the microstructure was completely different; from Figure 22.17, shown in Figure 22.16, consisted of tempered martensite.

Figure 22.16 Optical photomicrograph of the failed axle outer perimeter region, which is composed of tempered martensite. 500×. [Reproduced with permission from *Handbook of Case Studies in Failure Analysis, Vol. 1* (1992), ASM International, Materials Park, OH, 44073-0002.]

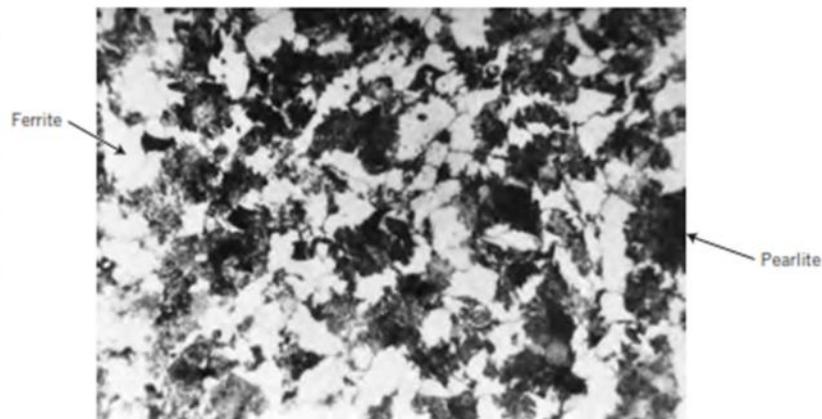
A photomicrograph of this region, it may be noted that the microconstituents are ferrite, pearlite, and possibly some bainite.

Figure 22.17 Optical photomicrograph of the failed axle central core region, which is composed of ferrite and pearlite (and possibly bainite). 500×. [Reproduced with permission from *Handbook of Case Studies in Failure Analysis, Vol. 1* (1992), ASM International, Materials Park, OH, 44073-0002.]

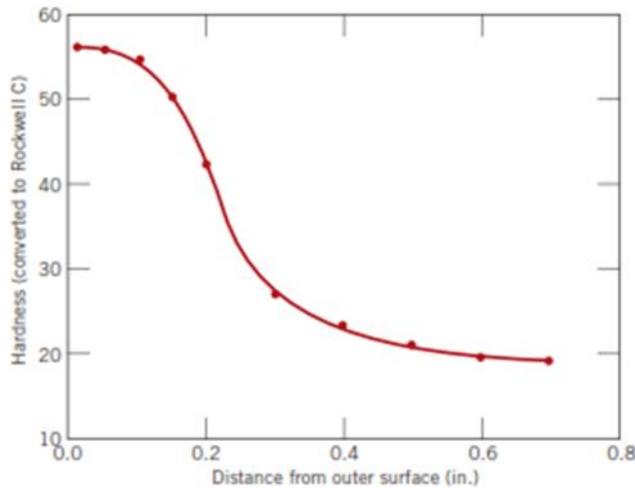
In addition, transverse microhardness measurements were taken along the cross section; in Figure 22.18 is plotted the resulting hardness profile. Here it may be noted that the maximum hardness of approximately 56 HRC occurred near the surface, and that hardness diminished with radial distance to a hardness of about 20 HRC near the center. On the basis of the observed microstructures and this hardness profile, it was assumed that the axle had been induction hardened. At this point in the investigation it was not possible to ascertain irrefutably whether the axle fracture caused the accident or whether the accident caused the fracture.

Figure 22.18 Transverse hardness profile across the axle cross section. (Microhardness readings were converted to Rockwell C values). [Reproduced with permission from *Handbook of Case Studies in Failure Analysis, Vol. 1* (1992), ASM International, Materials Park, OH, 44073-0002.]

The high hardness and, in addition, the evidence of cleavage of the outer surface layer indicated that this region failed in a brittle manner as a result of being overloaded (i.e., as a result of the accident). On the other hand, the evidence of a mixed ductile-brittle mode of fracture in the central region neither supported nor refuted either of the two possible failure scenarios.

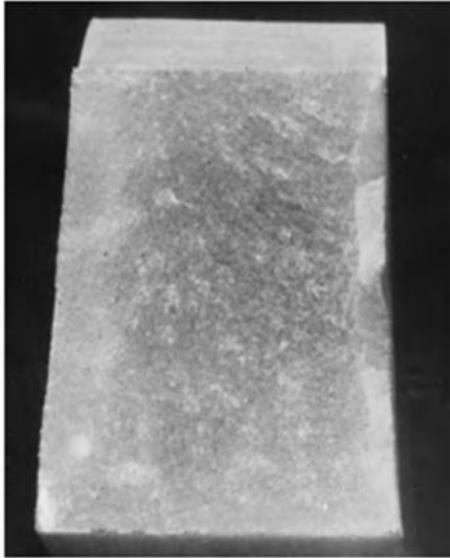
Figure 22.19 Fracture surface of the Charpy impact specimen that was taken from the outer perimeter region. [Reproduced with permission from *Handbook of Case Studies in Failure Analysis, Vol. 1* (1992), ASM International, Materials Park, OH, 44073-0002.]

Furthermore, the appearances of the fracture surfaces for the two specimens were dissimilar. Very little, if any, deformation was observed for the outer perimeter specimen (Figure 22.19); conversely, the core specimen deformed significantly (Figure 22.20).

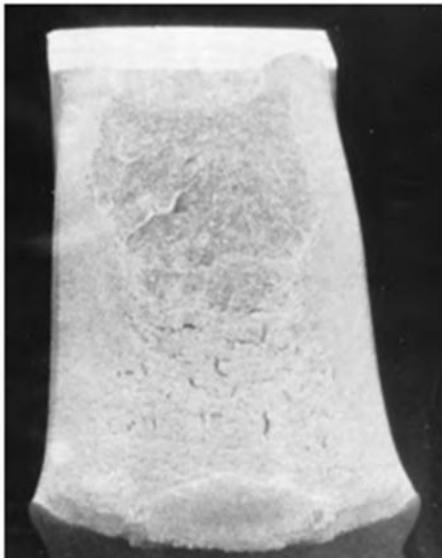
Figure 22.20 Fracture surface of the Charpy impact specimen that was taken from the central core region. [Reproduced with permission from *Handbook of Case Studies in Failure Analysis, Vol. 1* (1992), ASM International, Materials Park, OH, 44073-0002.]

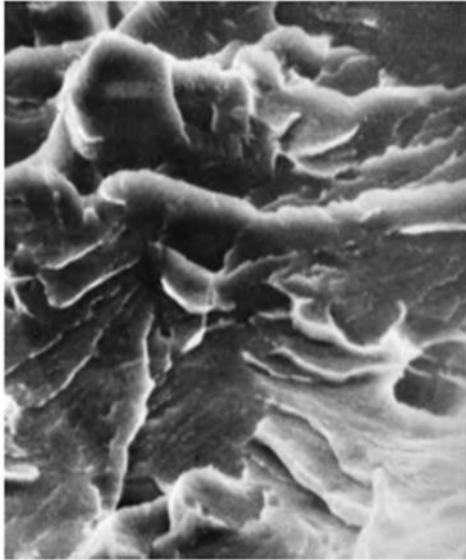
Figure 22.21, a micrograph of the outer-periphery specimen that was impact tested, reveals the presence of cleavage features, which indicates that this was a brittle fracture.

Figure 22.21 Scanning electron micrograph of the fracture surface for the impact specimen prepared from the outer perimeter region of the failed axle. 3000 \times . [Reproduced with permission from *Handbook of Case Studies in Failure Analysis, Vol. 1* (1992), ASM International, Materials Park, OH, 44073-0002.]

Furthermore, the morphology of this fracture surface is similar to that of the actual failed axle (Figure 22.14).

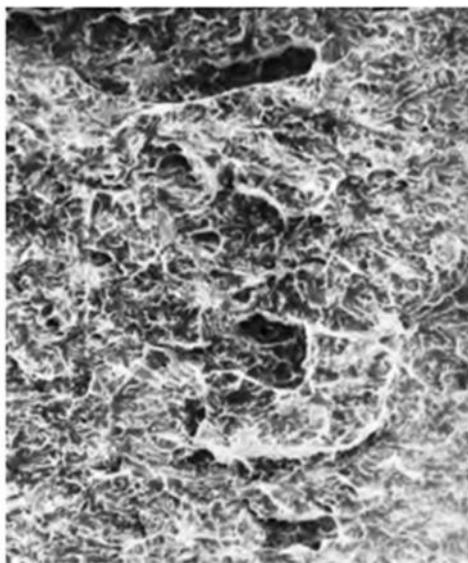
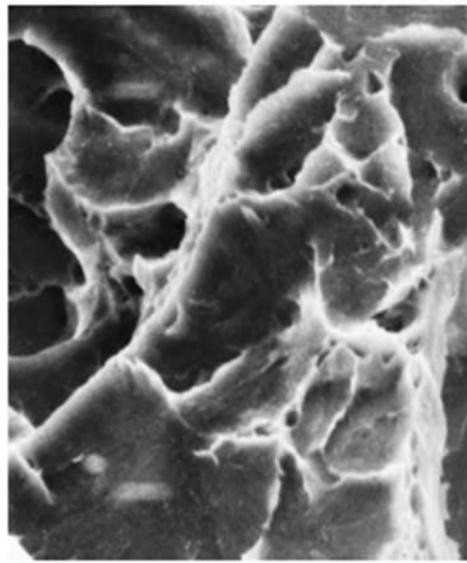
For the impact specimen taken from the center-core region the fracture surface had a much different appearance; Figures 22.22a and 22.22b show micrographs for this specimen, which were taken at relatively low and high magnifications, respectively.

These micrographs reveal the details of this surface to be composed of interspersed **cleavage features and shallow dimples**, being similar to the failed axle, as shown in Figure 22.15. Thus, the fracture of this specimen **was of the mixed-mode type**, having both ductile and brittle components.

Figure 22.22 (a) Scanning electron micrograph of the fracture surface for the impact specimen prepared from the center-core region of the failed axle. 120 \times . (b) Scanning electron micrograph of the fracture surface for the impact specimen prepared from the center-core region of the failed axle taken at a higher magnification than (a); interspersed cleavage and dimpled features may be noted. 3000 \times . [Reproduced with permission from *Handbook of Case Studies in Failure Analysis, Vol. 1* (1992), ASM International, Materials Park, OH, 44073-0002.]

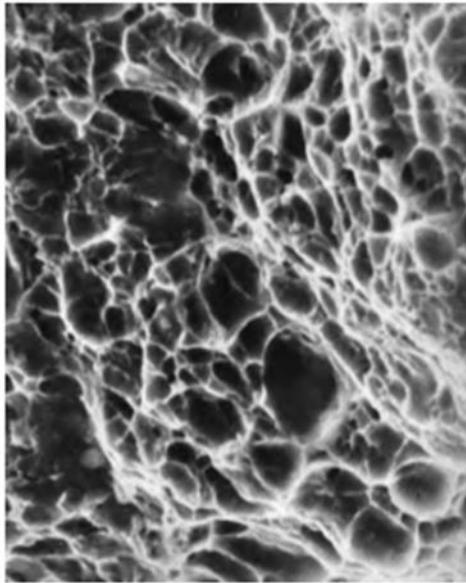
A fracture surface was examined using the SEM, and its morphology is presented in the micrograph of Figure 22.23. The

Figure 22.23 Scanning electron micrograph of the fracture surface for the inner-core specimen that was tensile tested; a completely dimpled structure may be noted. Approximately 3500 \times . [Reproduced with permission from *Handbook of Case Studies in Failure Analysis, Vol. 1* (1992), ASM International, Materials Park, OH, 44073-0002.]

The surface was composed entirely of dimples, which confirms that this material was at least moderately ductile and that there was no evidence of brittle fracture. Thus, although this center-core material exhibited mixed-mode fracture under impact loading conditions, when the load was applied at a relatively slow rate (as with the tensile test), failure was highly ductile in nature.

On the basis of the tensile tests (i.e., slow strain-rate tests) performed on this core region, the appearance of the axle fracture **surface** would be **entirely ductile** (i.e., dimpled, as per the SEM micrograph of Figure 22.23). Inasmuch as this core region of the failed shaft exhibited mixed (**ductile and brittle**) mode fracture features (**both cleavage features and dimples**, Figure 22.15), and not exclusively dimples, the axle-failure-caused-the-accident scenario was rejected.
