Experimental Study on Shear Strengthening of Reinforced Concrete Beams Using Different Techniques of Concrete Jacketing

Mohammed F. Ojaimi ¹

¹ Department of Civil Engineering, College of Engineering, University of Basrah, Basrah, Iraq

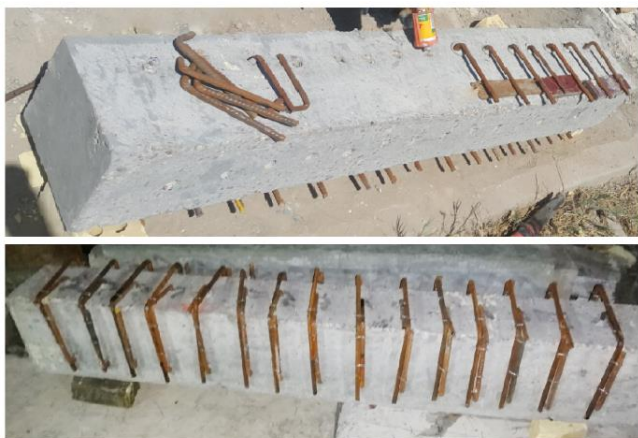
Fig. 4 Details of the beam (S.-J. + Stirrup).

As shown in Fig. 4, the dimensions of the concrete jacket were the same as the previous one. The difference between the strategy used to strengthen this beam and the previous one is in the details of the concrete mixture and the addition of stirrups instead of using steel fiber. The concrete jacket was cast by Self Compacted Concrete (SCC) after adding stirrups. Details of the added shear reinforcement in the concrete jacket are shown in Fig. 4. The mixture proportion and the mechanical properties of the hardened (SCC) mixture are presented in Tables 8 and 9, respectively. The mix design used in (SCC) is the same as (SCFRC) that used in the beam (S.-J. + Stirrup) with the difference of cancellation the steel fiber, which led to a decrease in the proportion of water and plasticizers necessary to obtain fresh mixture within the self-compacted concrete requirements.

When the beam (Jac. + Stirrup) reached 28 days' age, the following steps were taken to strengthen it. The first step was to prepare the concrete substrate by grinding its face using a rotary diamond grinder. Then holes of 8 cm deep and 12 mm diameters were made by an electric drill. The holes were made on the concrete surface in the locations specified to add anchors. Steel reinforcement of 10 mm diameters (D10) with angle shape was used as a shear connector. The details and the dimensions of the anchors are presented in Fig. 4. The beam surfaces and the drill holes were cleaned using compressed air. Then the shear connectors were installed by using Sika AnchorFix®-2 + Tropical epoxy resin. Then, after the end of the five-hours curing period, the stirrups were bonded to the anchors. The mechanical and physical properties of the Sika AnchorFix®-2 + Tropical epoxy resin are summarized in Table 10. Then after completing the process of adding shear reinforcement, the beam was cleaned and remolded. A 1 mm layer thickness of the Sikadur®-32 LP was applied to the concrete. Finally, the (SCC) jacket was cast and cured for 28 days by a wet burlap cover.

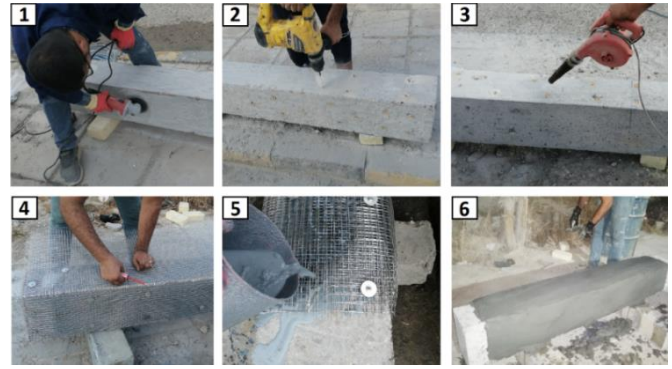
Fig. 6 The steps involved in the strengthening of the beam (S.-J. + Ferrocement).

When the age of the beam becomes 28 days, the sample was prepared for strengthening. The concrete surface was roughened by a grinder, many holes were drilled randomly on the concrete surface, the holes and concrete surface cleaned using compressed air, then the plastic fisher screws were inserted inside the holes (see Fig. 6 (1-3)). The pre-prepared six layers of U wrap steel wire mesh was applied on the three sides of beam faces (the web and the tension zone) and mechanically fixed by using bolts and washers (see Fig. 6 (4)). The pre-prepared bonding bridge liquid was applied to the concrete surface (see Fig. 6 (5)). Finally, the beam was plastered with a 20 mm thick high-quality adhesive mortar and cured for 28 days by a wet burlap cover as shown in Fig. 6 (6).

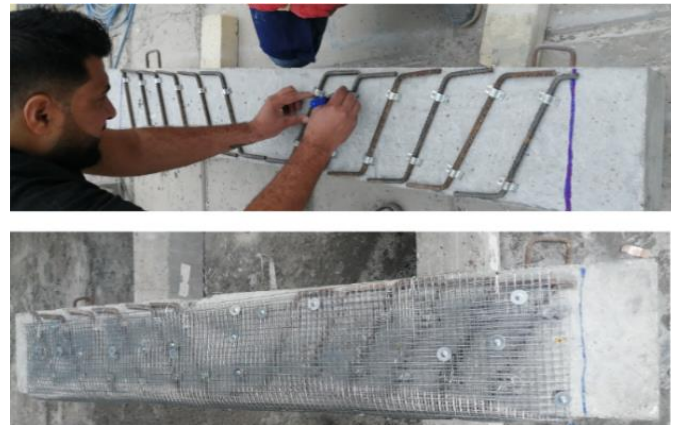
Fig. 7 The configuration of the externally bonded steel rebars used in the strengthening of the beam (S.-J. + Ferrocement + R).

This specimen was strengthened in the same way and the details used in the previous one, with the difference that external steel reinforcing bars were added and mechanically connected on the surface of the beam before the wire mesh wrapping. As shown in Fig. 7 twelve deformed bars of 10 mm (D10) were used on each side of the beam web. The added steel bars were distributed at a distance of 80 mm center to the center and were arranged to be perpendicular on the path connecting the loading point and the beam support.

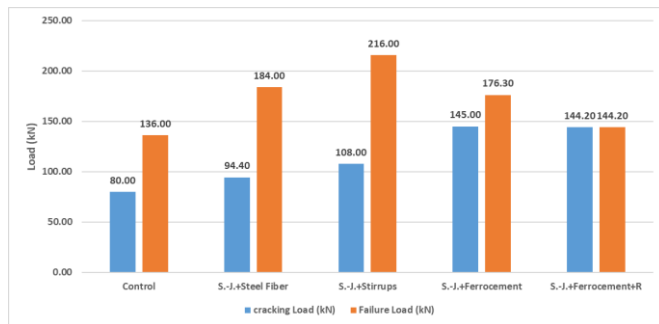
**Fig. 8** The cracking and failure load for all the studied beams.

The results of all the studied beams will be discussed in this section. The results include the total ultimate failure load (P_{UF}), the ultimate deflection that corresponds to the ultimate failure load (Δ_U), cracking load (P_{crack}), midspan deflection, crack propagation, and the final failure mode. The results of all the studied beams are summarized in Tables 13 and Figs. 8 and 9.

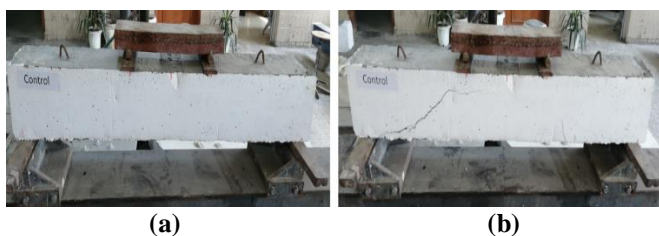
**Fig. 10** The control beam (a) before the test and (b) after the failure.

The control beam displayed a shear failure by forming a major diagonal crack. The first crack appears at a total applied load of 80 kN. The crack was initiated near the support and then propagated to the load application point as the load continues to increase. The complete collapse occurred at a total applied load of 136 kN, and the corresponding ultimate mid-span deflection (Δ_U) was 4.87 mm. Fig. 10 shows the control beam (a) before the test and (b) after the failure.

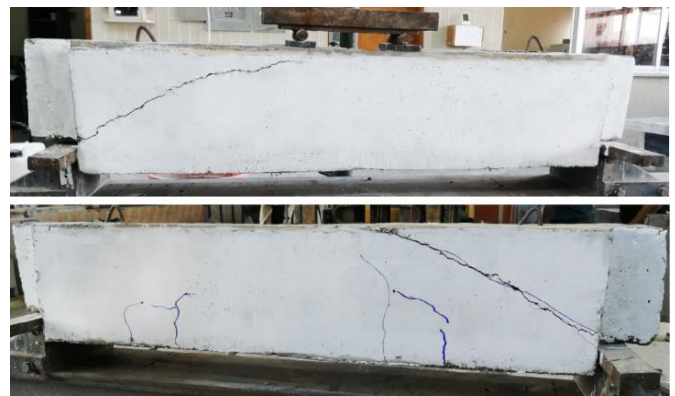
**Fig. 11** The (S.-J. + Steel Fiber) beam after the failure.

As presented in Table 13 the specimen (S.-J. + Steel Fiber) contributed to increasing the load-carrying capacity of the unstrengthen beam by 35 %. The specimen failed due to a significant diagonal crack. The shear crack was initiated under the edge of the loading plate at 94.4 kN applied load, then propagated toward the support point. The beam failed at a 184 kN load with a 5.63 mm corresponding deflection. Fig. 11 shows the two web faces of the (Jac. + Steel Fiber) specimen after failure.

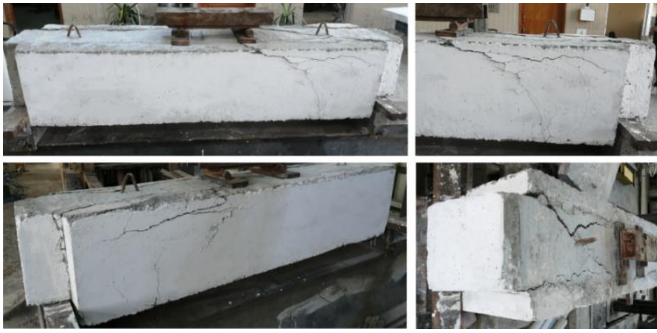
Fig. 12 The (S.-J. + Stirrup) beam after the Testing.

The initial and ultimate failure load of the specimen (Jac. + Stirrup) was 108 kN and 216 kN, respectively. In comparison with the unstrengthen beam, there is a 59 % increase in the load-carrying capacity and a 35 % delay in the initial failure occurrence. The deflection was $\Delta_U = 6.3$ mm at the ultimate load. The beam demonstrates a considerable increase in the shear capacity and the stiffness of the original beam. It was found through the study that the strategy used to strengthen this beam is considered the best approach among all the methods used to enhance the rest of the specimens. Fig. 12 shows the (Jac. + Stirrup) specimen after testing.

The failure mechanism started with the appearance of a vertical crack at the end of the concrete jacket. The crack was initiated on the surface of the original beam and above the edge of the support plate. The crack extended until it arrived at the top surface of the specimen. As shown in Fig. 12, when the applied load approached the ultimate failure load, some cracks appeared on the cover of the concrete jacket. At the final failure load, the beam failed in explosive mode, and widespread cracks appeared on the upper surface of the original specimen.

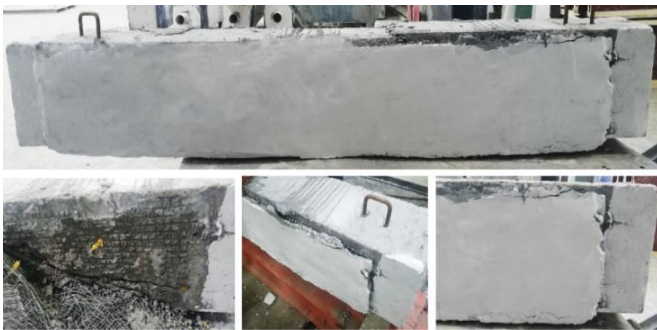
Fig. 13 The (S.-J. + Ferrocement) beam after the failure.

The ferrocement jacket contributed to enhancing the initial and ultimate failure load by 81 % and 30 %, respectively. The technique used in strengthening this beam significantly improved the shear capacity in terms of cracking load. The first shear crack appeared when the applied load reached 82 % of the ultimate failure load. When the applied load became 145 kN a narrow crack appeared near the support plate on the jacket surface. With the increase in applied load, the crack began to expand towards the loading point until the applied load reached the ultimate failure load at 176.3 kN. Debonding of the ferrocement layer occurred at the ultimate failure load, which was accompanied by a sudden shear failure. Fig. 13 shows the specimen S.-J. + Ferrocement after the failure.
