Rehabilitation of RC deep beams failing in shear using CFRP sheets and steel plates.

Abstract

Keywords: Deep beams, Shear failure, Rehabilitation, CFRP sheets; Steel plate

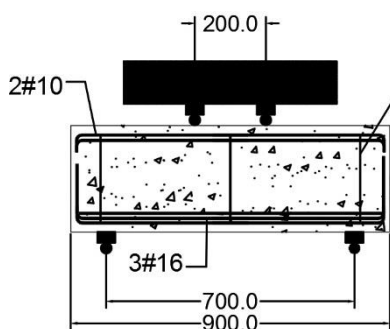
Fig. (1): Details of loading and specimens for (a/d) = 1

A schematic of the test specimens and reinforcement layout is depicted in Fig. 1. The cross-section of all specimens was identical (180×300) mm; three different ratios of (a/d) have been employed (a/d=1,1.5, and 2). Table 1 presents a total of nine specimens that were tested under a two-point load with a 200 mm fixed distance between the load for all specimens. The specimens include three control beams (DB-1-CS-CFRP ,DB-1.5-CS-CFRP and DB-2-CS-CFRP) were loaded up to failure, six specimens with an initial per-load (80% of the ultimate load), namely (DB-1-RS-CFRP ,DB-1.5-RS-CFRP, DB-2-RS-CFRP) and (DB-1-RS-SP , DB-1.5-RS-SP, DB-2-RS-SP) retrofitted with either carbon fiber reinforced polymer or steel plates, after being grouted with cementitious grout to fill the cracks of the initially loaded component and replacement the damaged part of concrete. The identification code DB-1.5-CS-CFRP or DB-1.5-RS-CFRP was assigned for each specimen . For example, "DB-1.5-CS-CFRP" stands for control deep beam element with (a/d) equal to 1.5, specimens "DB-1.5-RS-CFRP", and " DB-1.5-RS-SP" stands for the elements initially loaded up to 80% of its ultimate capacity and rehabilitated with CFRP or steel plate, respectively.

The beams were designed to fail in shear, 3Ø16mm flexural reinforced were used with 2Ø8 stirrups were provided at the ends of all specimens.

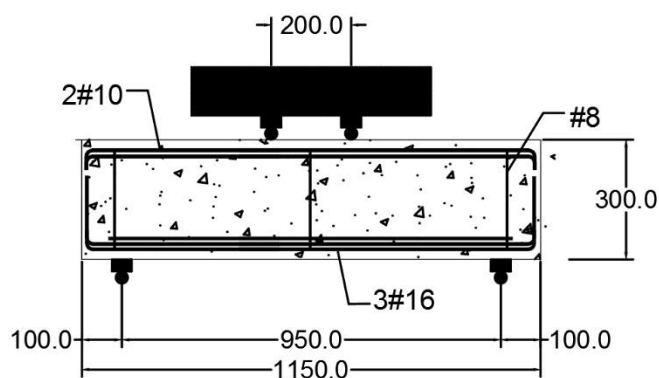
Fig. (2): Details of loading and specimens for (a/d) = 1.5

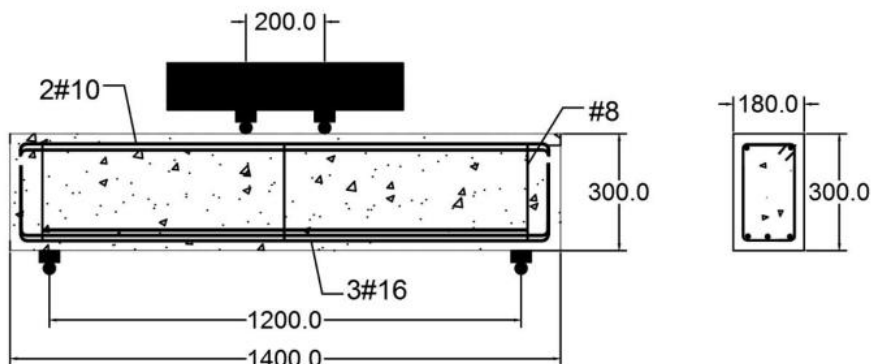
Fig. (3): Details of loading and specimens for (a/d) = 2

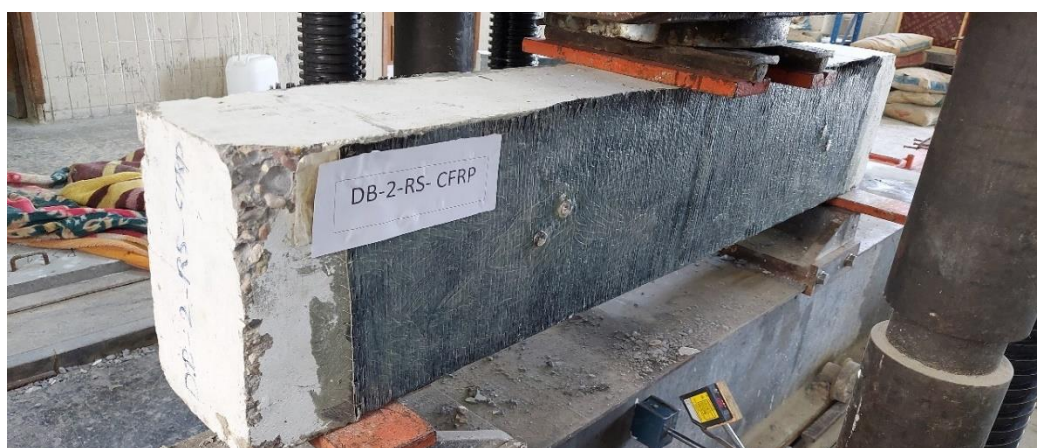
Fig.5 Simply supported reinforced deep-beam under two axial load,

3. Test Setup : The beam-specimens were tested over a simply supported span of 700, 950, 1200mm, as illustrated in Fig.(5). Two point loads were applied; the distance between two point loads was 200mm. The beam test was started by the application 100kN load to set and check the dial gages then unloading to zero. At zero loading, the initial reading of the dial gage. Then, the load was increased gradually in steps, while the strain, and deflection measurements were recorded simultaneously until failure occurs. A magnifying glass was used to detect the cracks at each load. Cracks were detected and drawn on the face of the tested beam.

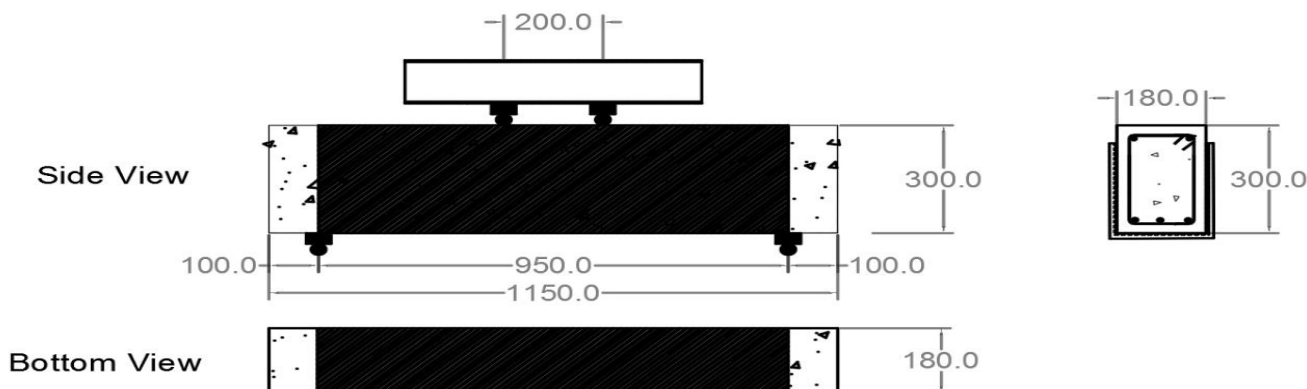
Figure (6): Details of external CFRP sheets for repaired beams in Shear.

The exterior steel plate was bonded to repair beams have depth (250 mm) on two side only constant thickness. As illustrated in fig(6)and fig(7)

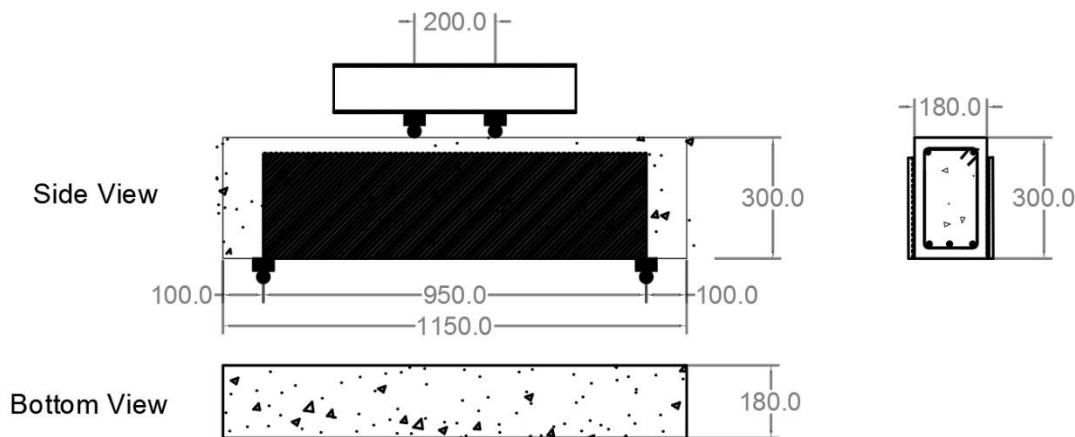
Figure (7): Details of external Steel Plates for repaired beams in Shear.

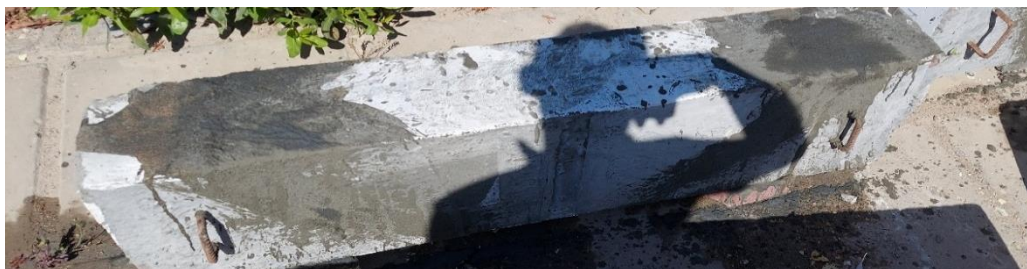
Fig (8). Repaired beams with cementitious grout

- The first step in repairing restore the original shape of the specimen. A reverse load is applied to the beam until it straightens out again, or almost so.
- Crushed concrete in the failure zone is chipped out in both tension and compression zones. Then, it is replaced by cementitious grout with higher properties than old concrete, as shown in Fig (8).

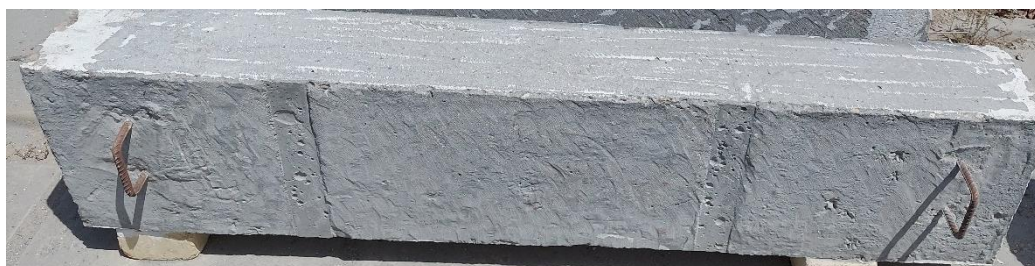
Figure (9): Cleaning surface of concrete and chamfered corners

- A surface cleaning machine was used to clear the concrete surface on all faces of the deep-beam sides, as illustrated in Fig .8. The specimen's two corners have been further chamfered with a radius of $R=10\text{mm}$ to avoid a reduction in strength caused by sheet bending at the corners, after which they were cleaned and dried.as shown in Fig (9)

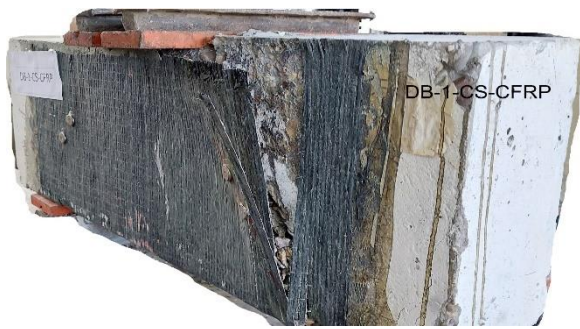
Figure (9): Failure mode for Rehabilitated Deep Beam with (a/d=1) failed in shear - DB-1-CS-CFRP

The control deep beams (DB-1-CS-CFRP, DB-1.5-CS-CFRP, and DB-2-CS-CFRP) did not show any increase in ultimate load since they fail before reaching their original capacity owing to complete beam damage. The beam (DB-2-RS-CFRP) achieves the best ultimate load result by with shear strength efficiency (154.4 percent). This beam collapse was due a new flexural shear crack in the opposite span, distant from the repaired cracks, creating substantial local interfacial stresses between the CFRP sheets layer and the concrete at the crack zone. This causes debonding or crushing of sheets beginning in this zone.

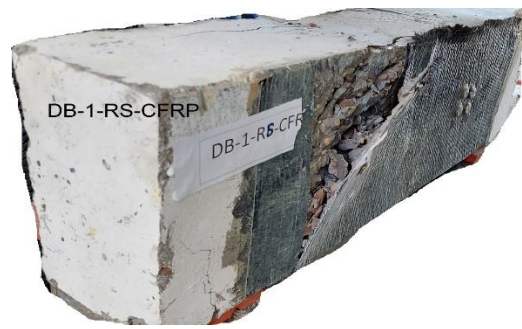
Figure (10): Failure mode for Rehabilitated Deep Beam with (a/d=1) failed in shear - DB-1-RS-CFRP

Beam (DB-1-RS-CFRP) fails by reopening healed cracks and debonding of sheet from one end that began under the crack zone. The use of epoxy glue is insufficient to achieve composite action between concrete and steel, and so cannot avoid debonding failure. This beam has a restored efficiency (96.1 percent).

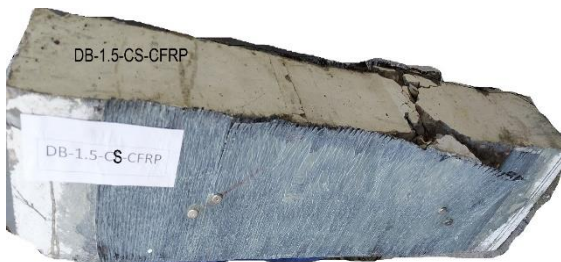
Figure (11): Failure mode for Rehabilitation Deep Beam with (a/d=1.5) failed in shear - DB-1.5-CS-CFRP

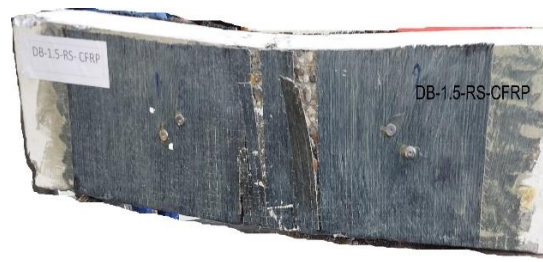
Figure (12): Failure mode for Rehabilitated Deep Beam with (a/d=1.5) failed in shear - DB-1.5-RS-CFRP

Beam (DB-1.5-RS-CFRP) has repaired efficiency (105.1%), and the beam failed due to the reopening of a previously repaired major shear crack that spreads across the width of the beams to the opposite face and a new failure mode develops in the flexural zone, resulting in the beam's final failure, with tearing off of the concrete cover and separation of CFRP sheets at this zone.

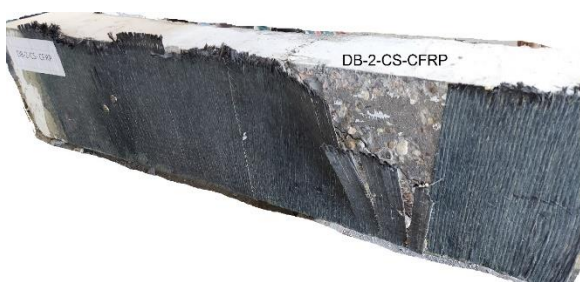
Figure (13): Failure mode for Rehabilitated Deep Beam with (a/d=2) failed in shear - DB-2-CS-CFRP

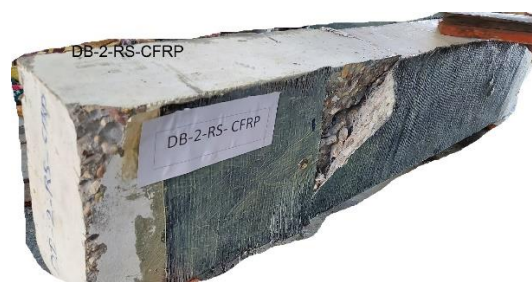
Figure (14): Failure mode for Rehabilitated Deep Beam with (a/d=2) failed in shear - DB-2-RS-CFRP

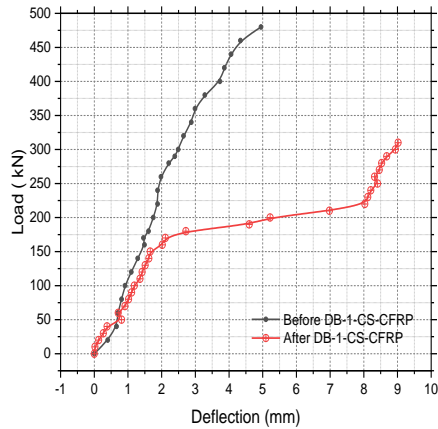
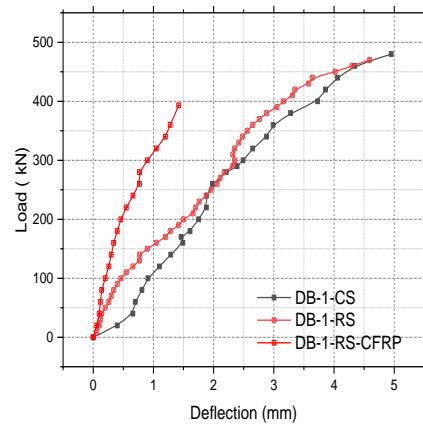
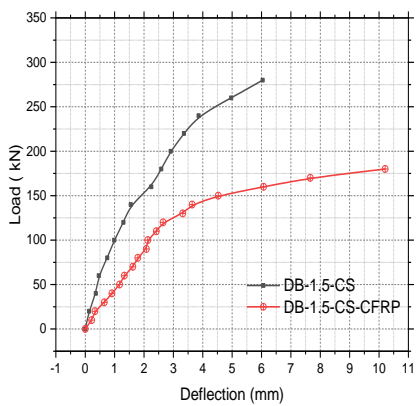
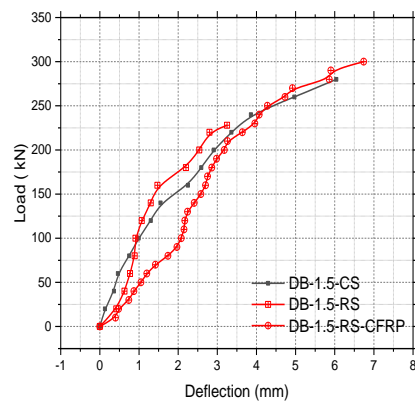
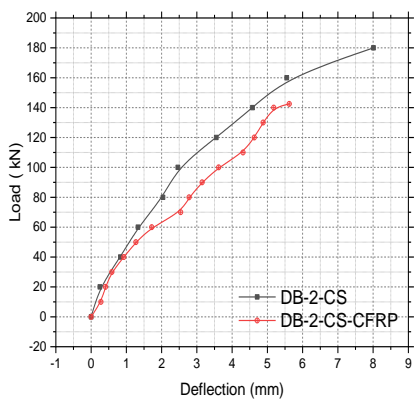
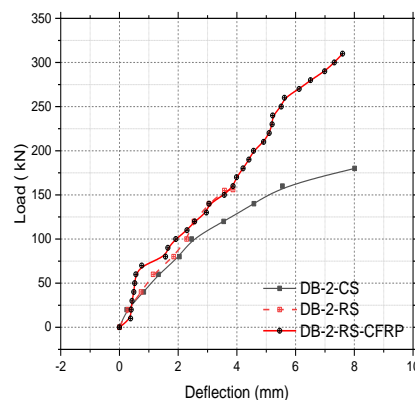
Fig.(15):Load-Deflection curve for beam(DB-1-CS-CFRP).

Fig.(16):Load-Deflection curve for beam(DB-1-RS-CFRP).

Fig.(17):Load-Deflection curve for beam(DB-1.5-CS-CFRP).

Fig.(18):Load-Deflection curve for beam(DB-1.5-RS-CFRP).

Fig.(19):Load-Deflection curve for beam(DB-2-RS-CFRP).

Fig.(20):Load-Deflection curve for beam(DB-2-RS-CFRP).

5.2.2 Deflection of repaired beams with CFRP sheets : The load-deflection curves are illustrated in Figs.(15) to (20), which show

the comparison of load vs. mid-span deflection for control, original (loaded to 0.8 Pu) and repaired beams. It can be noticed that for beams loaded to failure then repaired with CFRP (DB-1-CS-CFRP, DB-1.5-CS-CFRP and DB-2-CS-CFRP), the deflections of the repaired beams (at 60% of ultimate load) are greater than their original beams by (361.3, 329.6 ,133.1 %) respectively.

The best deflection is achieved in beam (DB-2-RS-CFRP), the repaired beam showed, at service load (which is 70% of ultimate load), (69.4 %) lower deflection compared to control beam deflection, which means a significant increase in stiffness which was provided by CFRP.

The deflection of repaired beam (DB-1-RS-CFRP) is lower than that of the original beam with ratio 87.0 %, and beam (DB-1.5-RS-CFRP) recorded ratio (108.2%) therefore, its showed lower stiffness.

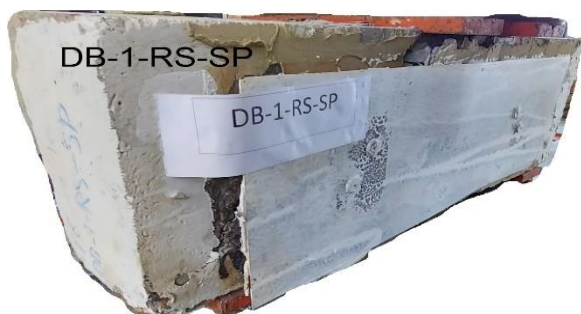
Figure (21): Failure mode for Rehabilitated Deep Beam with ($a/d=1$) fail in shear - DB-1-RS-SP

Beam (DB-1-RS-SP) has a repaired efficiency of 96.3 percent, but fails in the same way as other beams that have been repaired due to shear damage, by reopening mended cracks and debonding steel plates from one end that started under the crack zone. The use of epoxy glue is sufficient to achieve composite action between concrete and steel, and so can avoid debonding failure. The stress concentration in the adhesive layer is considered to initiate the debonding of plates or concrete covers glued to reinforced concrete beams.

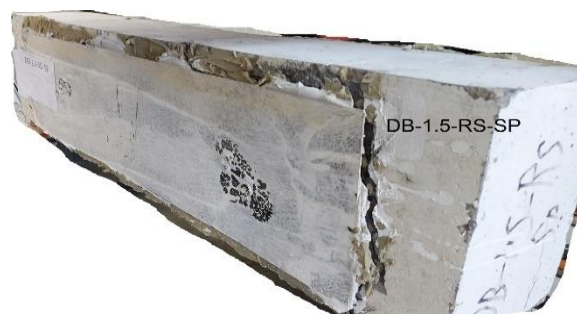
Figure (22): Failure mode for Rehabilitated Deep Beam with ($a/d=1.5$) fail in shear - DB-1.5-RS-SP

Beam (DB-1.5-RS-SP) has repaired efficiency 141.1 percent. Reopening of a previously repaired major shear crack caused the concrete cover to tear off and the steel plate zone to separate in this beam, which led directly to its failure.

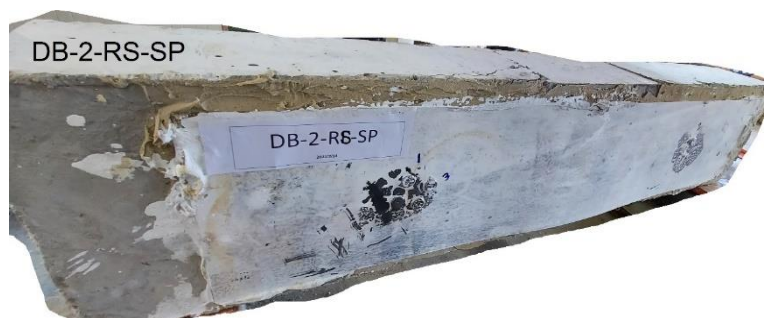
Figure (23): Failure mode for Rehabilitation Deep Beam with ($a/d=2$) fail in shear - DB-2-RS-SP

The beam (DB-2-RS-SP) achieves the best ultimate load result by recording repairing shear strength efficiency (179.5 percent). This beam collapses as a result of a new flexural shear crack that extends towards the point of applied loads, creating substantial local interfacial stresses between the steel plate layer and the concrete at the crack zone. This causes plate debonding to begin in this zone.

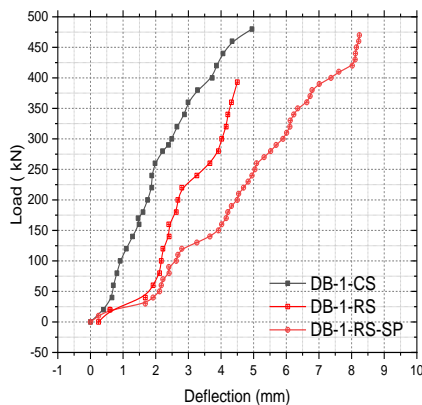
Fig.(24):Load-Deflection curve for beam(DB-1-RS-SP) compare with deflection of control beam.

Figure (24) shows the deflection of beam (DB-1-RS-SP) which is (217.4%) higher than that of the control beam at service load, which can be related to the difference in stiffness between the integrated (original) beam and the bonded (repaired) beam, as well as the presence of hair line cracks in the repaired beam.

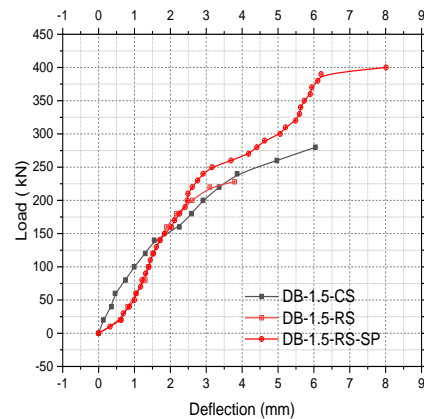
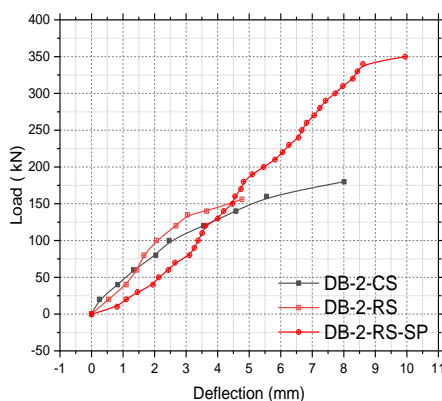
Fig.(25):Load-Deflection curve for beam(DB-1.5-RS-SP) with compare with deflection of control beam.

Fig.(26):Load-Deflection curve for beam(DB-2-RS-SP) compare with deflection of control beam.

Fig (25 and 26) illustrates that, for beams (DB-2-RS-SP and DB-1.5-RS-SP), the deflections, at service load, of the repaired beams are smaller than those of the control beam's with ratios of (94.6, 84.4 %) respectively.
