# The efficiency of CFRP strengthening and repair system on the flexural behavior of RC beams constructed with different concrete compressive strength

Meyyada Y. Alabdulhady<sup>\*</sup>, Mohammed F. Ojaimi, Aqeel H. Chkheiwir

Department of Civil Engineering, University of Basrah, Basrah, Iraq

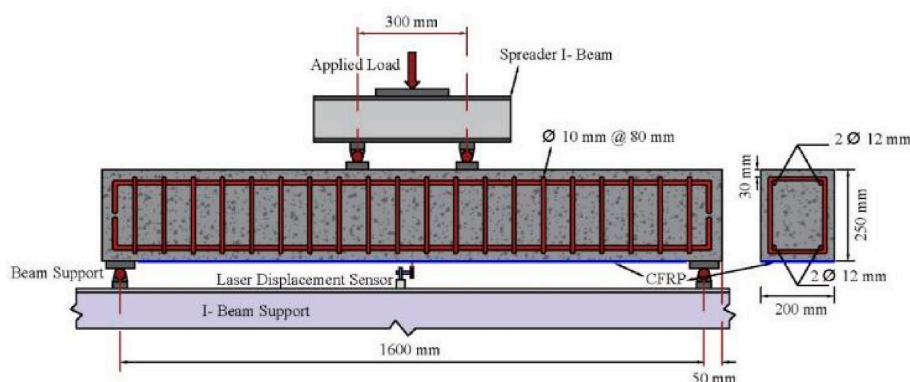
**Fig. 1.** Beams dimensions and reinforcement details.

proportions for all series are listed in Table 1. For each series, concrete compressive strength was determined as the average of three 150 mm cubes according to BS EN 12390-3:2009 [33], while splitting tensile strength of each group was obtained from the average of three cylinders with dimension of (diameter:150 mm, length: 300 mm) according to ASTM C496M [34]. All specimens in this campaign (beams, cubes, and cylinders) were casted at the same time and cured in the same manner by covering all the specimens with damp burlap. The curing lasted for several days based on the compressive strength gained with considering reaching to 70% of the required compressive strength. Then all specimens kept together under the same conditions in the lab until the testing day. The properties of the concrete are summarized in Table 3 and all the required tests for the mechanical properties of internal reinforcement and concrete are shown in Fig. 2.

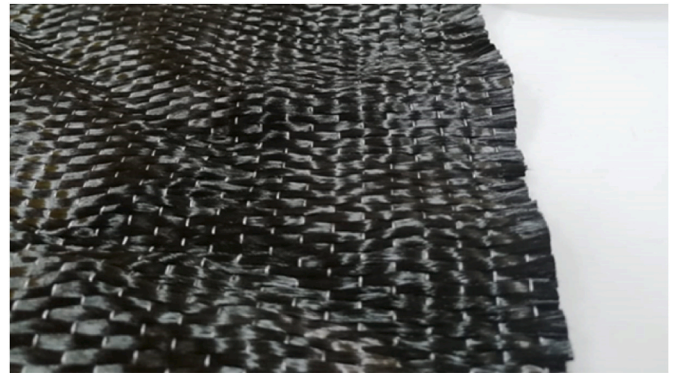
Fig. 3. Carbon fabric.

epoxy agent. The carbon fabric was SikaWrap®-300C [38] which is a unidirectional woven fiber shown in Fig. 3, with the manufactural properties listed in Table 5. The adhesive agent that is used for attaching the carbon fibric sheet to the concrete substrate was Sikadur®-330 epoxy [39]. The epoxy agent consists of two-component which are thixotropic epoxy-based impregnating resin and adhesive which is used for attaching the carbon fabric sheet to the concrete substrate. The mechanical properties of the epoxy adhesive, Sikadur®-330, based on the datasheet provided by the supplier are listed in Table 6.

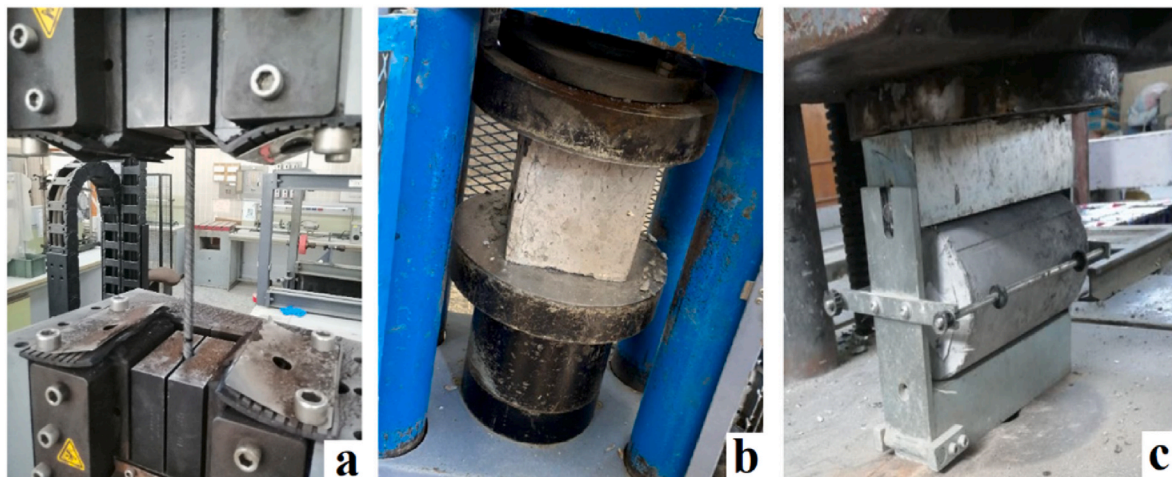
Fig. 2. Mechanical properties tests for a) rebar tensile strength b) concrete compressive strength c) splitting tensile strength.

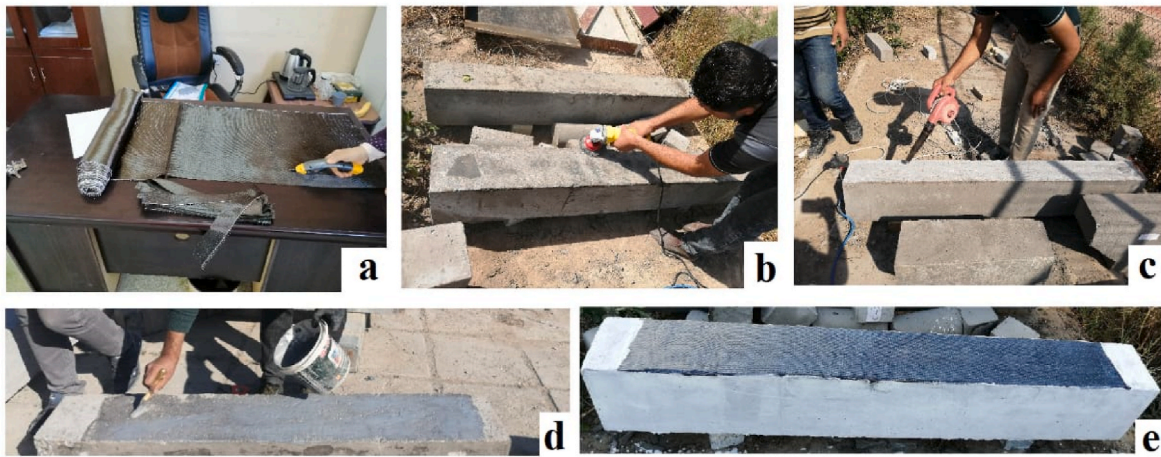
**Fig. 4.** Composite installation procedure for strengthened beams a) cutting the fabric b) roughen the tension surface c) surface cleaning d) applying the epoxy resin then the fabric e) finished surface.

The strengthening and repair procedures that were followed in this work are summarized below and illustrated in Fig. 4:

1. For each beam, the Carbon fabric was cut into the desired length and width (i.e., 200 × 1500) mm.
2. To ensure a good bond between concrete and CFRP system, a grinder was used to roughen the tension surface of the beam, the lower face of the beam.

3. An air blower was used to remove all dust and dirt in order to clean the roughened surface.
4. The two epoxy agents were mixed properly by following the instruction in Sikadur®-330 datasheet [38]. For each beam, a thin layer of prepared epoxy agent was applied on the tension surface.
5. A dry method was used to install the strengthening system. The dry fabric was fixed on the fresh epoxy layer by pressing with hand first

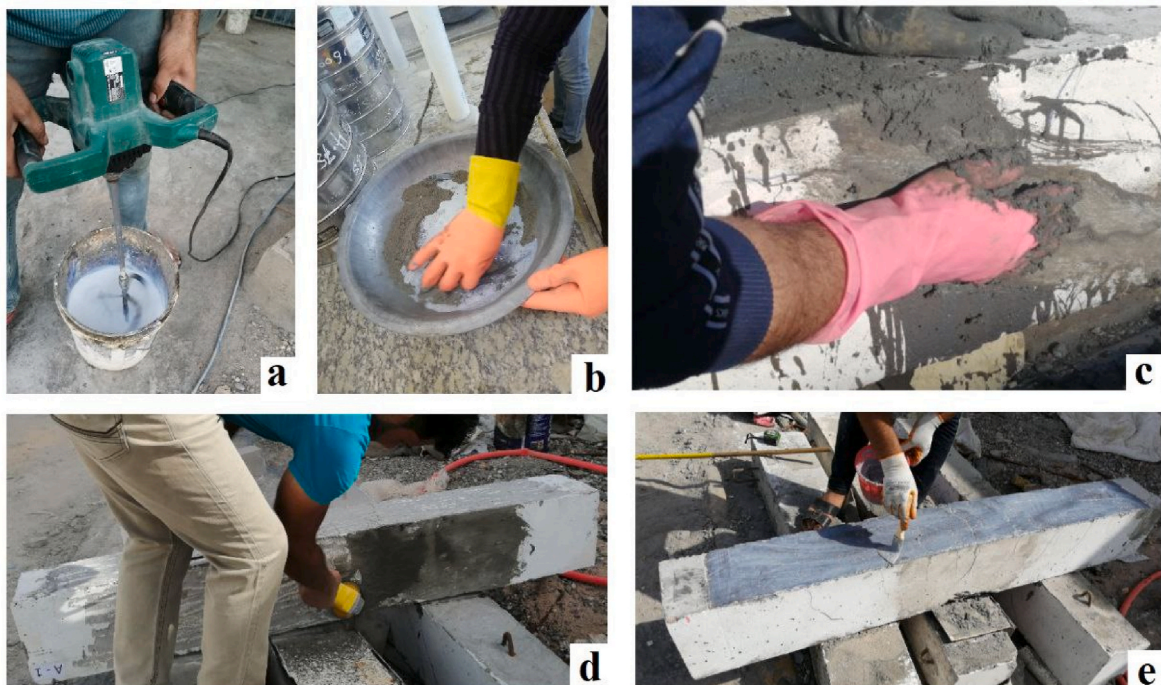
**Fig. 5.** Repair procedure a) blending the SikalateX with water b) mixing cement and sand with the wet part c) applying the repair mortar on the damaged area d) flatten and roughen the tension surface e) applying the epoxy resin then the fabric.

6. For repaired beams, all the damaged concrete parts of the tested control beams for all series were removed and the surface was cleaned from any dust or loose material. In this procedure, SikalateX [40] which is a water-resistant bonding agent and mortar admixture with manufacture properties listed in Table 7, was used as a replacement of all the damaged concrete parts and sealing the cracks. The mix and application process of SikalateX as a repair mortar was followed as mentioned in the data sheet [40]. SikalateX was blended with the same portion of water and then added to a dry mix of cement and sand, mixed well then applied on the concrete surface. The repaired beams were left seven days for curing of the repair mortar before steps 2 to 5 were followed. The repair sequence is shown in Fig. 5. All beams (strengthened and repaired) were left at least seven

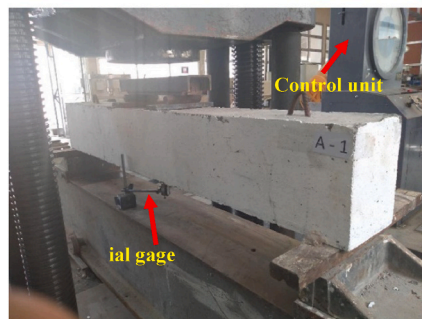
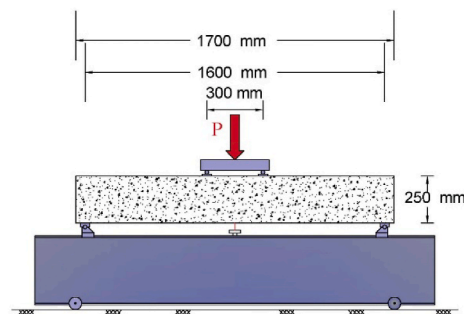
Fig. 6. Details of the test setup.

The beams under investigation were subjected to four-point bending test. The details and the locations of the four points loads are illustrated in Fig. 6. To apply the load on the specimens, a Universal Testing Machine (UTM) with a maximum load capacity of 500 kN was used. The beams were considered as simply supported with clear space of 1600 mm between the supports (Fig. 6). Midspan deflection was measured by using a digital laser dial indicator which is more accurate than the other gauges for precise reading. A load control protocol was performed with a constant load increment of 5 kN per min until the failure of the specimen. When the first crack occurred, the load was suspended for few seconds to label the cracks and to take pictures.

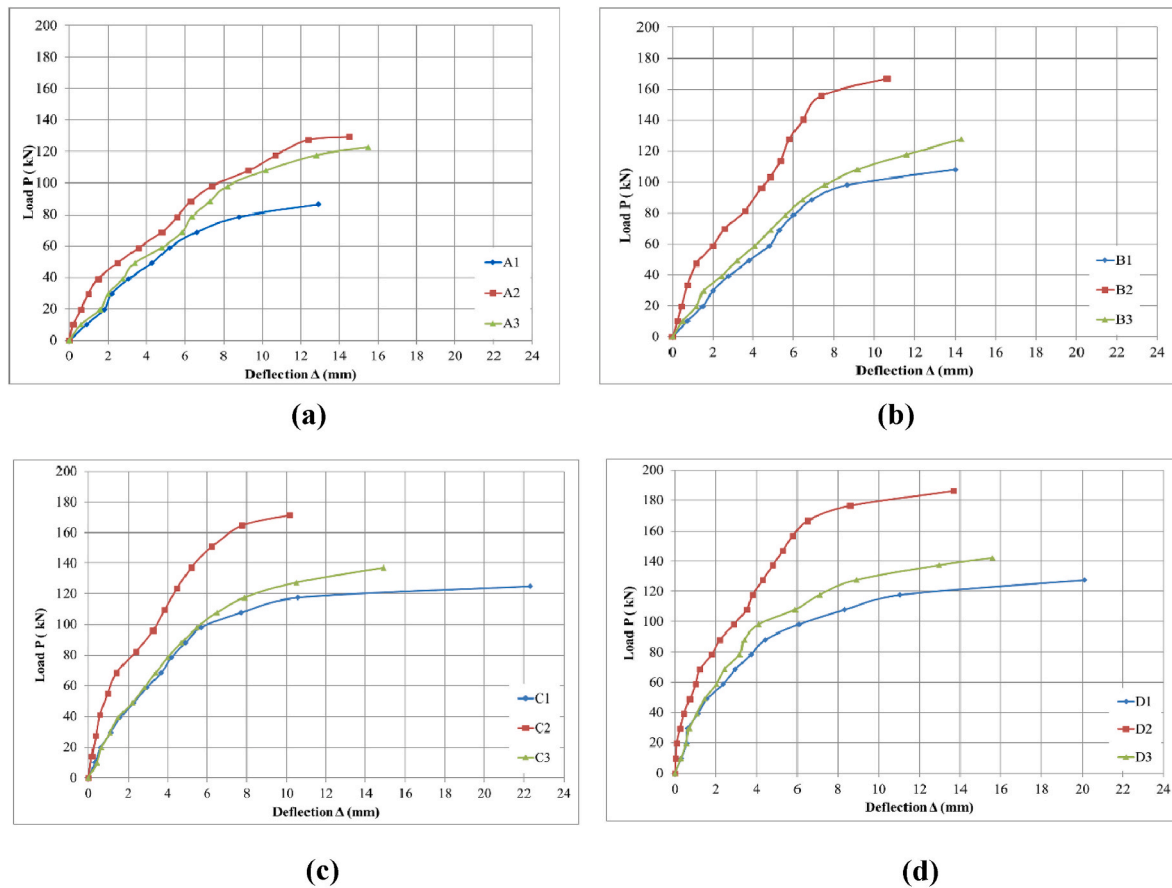
Fig. 7. Load deflection relationship.

Fig. 7 shows the experimental relationship between applied load and mid-span deflection curves for the tested beams. The summary of experimental results is listed in Table 8. The test results in Table 8 includes the ultimate applied load  $P_u$  which is the largest load (the ultimate) was carried by the beams and corresponding deflection  $\Delta_u$  which measured at beam midspan. The overall behavior of control beam in each series exhibited the same trend. This behavior can be divided into three phases. The elastic behavior phase characterized by a linear trend until the first crack initiated from the tension zone (the lower face of the beam) occurred. Then the second phase described by a non-linear behavior phase with a reduction in the bending stiffness due to the cracked section of the beam. The last phase started with yielding of steel bars in the tension zone and ended with reaching to the maximum applied load (failure load). For the strengthened and repaired beams, the overall behavior (i.e., load-deflection response) was the same with the behavior of the control beam except for the last phase, the external CFRP system contribution engaged as an additional reinforcement for carrying the additional applied load with the internal reinforcement until failure.

The load deflection response of strengthened beams clearly showed the high impact of the CFRP composite system on the overall behavior in compare with the control beam for all series as illustrated in Fig. 7. The uncracked section had a stiffer behavior in compare with the stiffness of the control beam as well as the repaired beam in all series. The highest increased in the load carrying capacity was for beam B2 with concrete compressive strength of  $f'_c = 36.1$  MPa. The improvement was up to 54.5% in compare with the control beam B1. Moreover, the contribution of the CFRP composite for the rest of the strengthened beams on the ultimate load was (50.0, 37.3 and 46.2) % for beams (A2, C2 and D2)

For repaired beams, the uncracked flexural stiffness trend and the overall behavior were the same in compare with the control beam in series with normal to high concrete compressive strength of  $f'_c = (36.1, 48.2$  and  $68.5)$  MPa, Fig. 7(b, c and d). A slight improvement in the ultimate load capacity up to (18.2, 9.8 and 11.6) % for beams (B3, C3 and D3) respectively. On the other hand, the repaired beam with low magnitude of concrete compressive strength of  $f'_c = 21.1$  MPa, beam A3, Fig. 7a, exhibited the same uncracked stiffness tendency as the control beam whereas the ultimate load capacity was considerably improved up to 44.9%. This recovery in repaired beams indicating that adding CFRP composite system as external reinforcement was a successful technique on restoring the original capacity and adding extra strength. This elaboration was tangible in beam with low concrete compressive strength with improvement up to 44.9%, while the enhancement decreased as the concrete compressive strength increased.

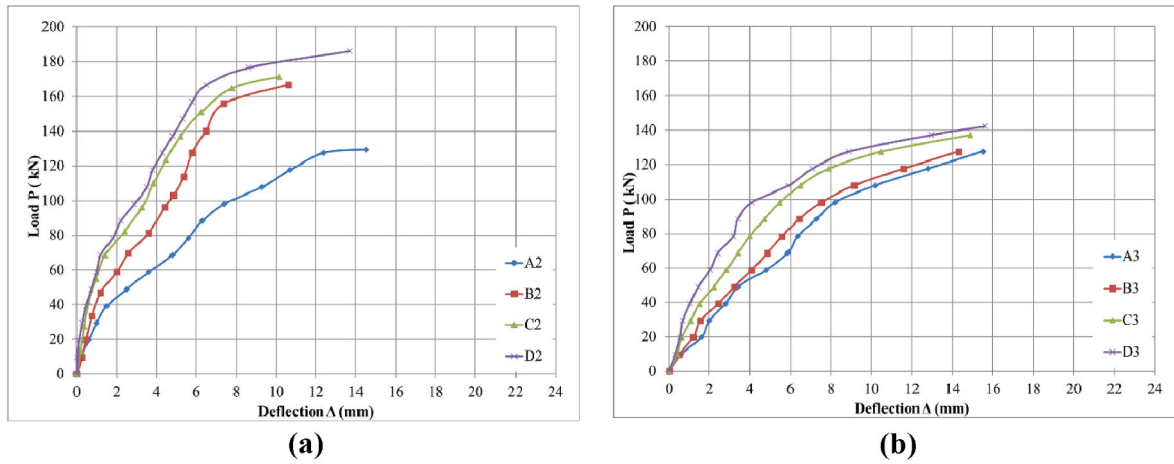
Fig. 8. Load-deflection relationship comparison for a) strengthened beams b) repaired beams.

To examine the contribution of CFRP system as an external flexural reinforcement with the influence of varying the concrete compressive strength on the strengthening and repaired beams separately, the strengthening beams from each series were collected together in one graph which is illustrated in Fig. 8a and similarly with the repaired beams as shown in Fig. 8b. CFRP system was more efficient in strengthened beams than the repaired beams by improving the strength. The improvement was noticeable for the strengthened beam B2 with concrete compressive strength of 36.1 MPa while the increase in the ultimate capacity was less prominent for beams with higher concrete strength. This significant improvement in the capacity can be related to the failure mode (fiber ruptured governed the failure for beam B2 which

will be discussed in the next section) or the value of concrete compressive strength of 36.1 MPa could be the saturation point for the current study. On the other hand, the repaired beams experienced a slightly improvement in the load carrying capacity as the concrete compressive strength increased (Fig. 8b). The overall behavior was nearly the same for all repaired beams. It should be noted that the performance of the CFRP composite material was inversely correlated to the concrete compressive strength in repaired beams while a proportion relation was observed in strengthened beams only with low to normal concrete strength.

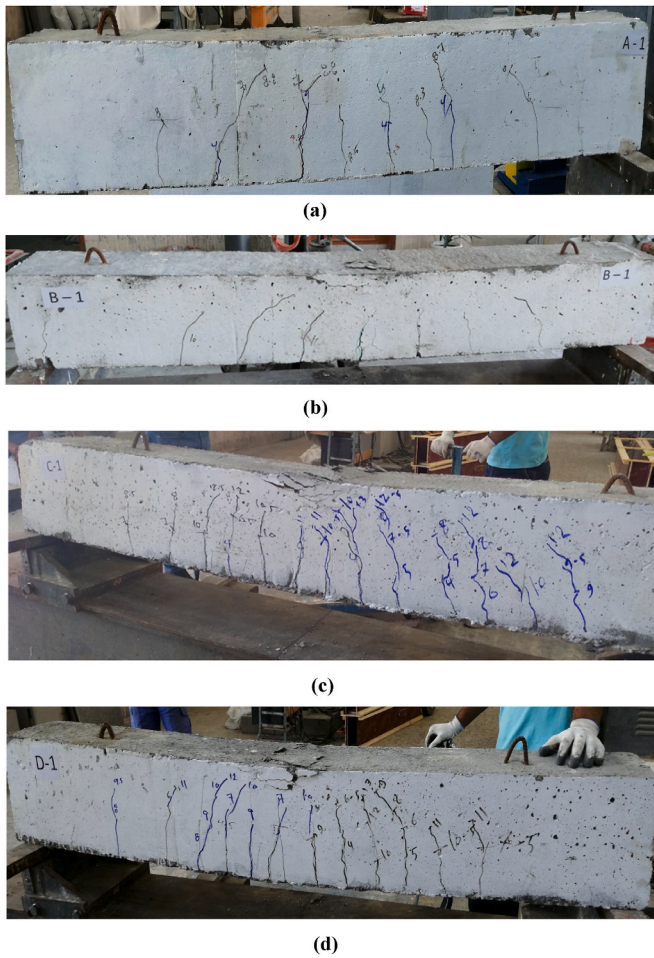
Fig. 9. Failure modes of control beams for a) C:21 b) C:36 c) C:48 d) C:68.

Failure modes for control, strengthened and repaired beams are shown in Figs. 9–11 respectively. A closer shoot to different modes of failure is illustrated in Fig. 12. Control beams in all series (A1, B1, C1, and D1) were failed due to yielding of the internal steel reinforcement in the tension zone followed by crushing of concrete in the compression zone at beam mid-span. Vertical flexural cracks first formed between the two-points load at the beam mid-span then propagated towards the compression zone as the load increased. Moreover, flexural-shear cracks appeared close to the supports and then spread with inclination across the compression zone.

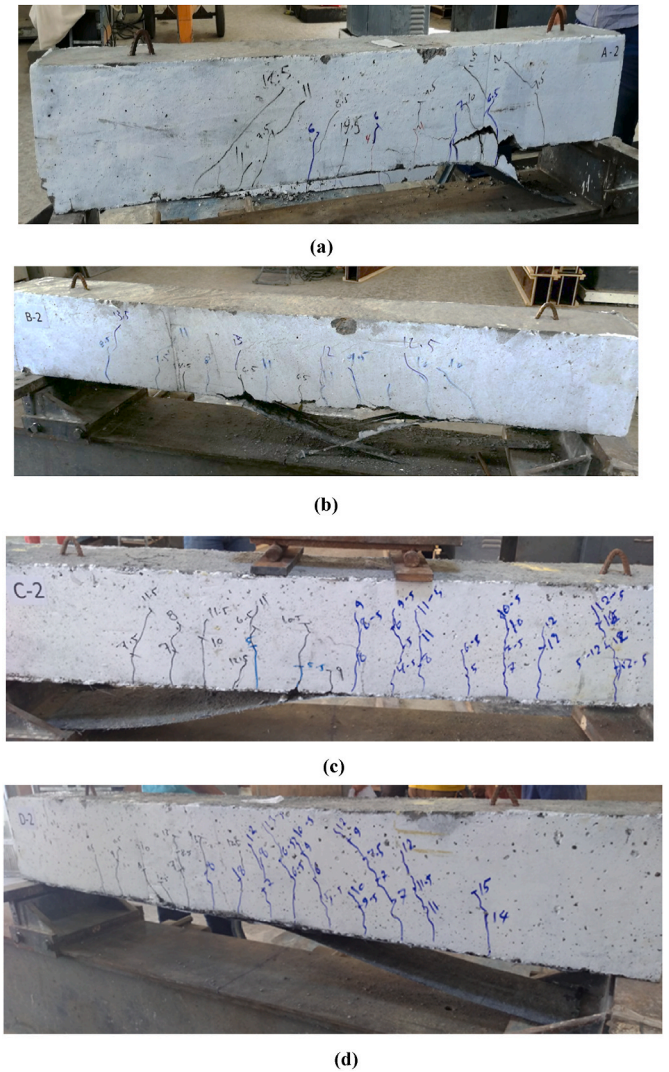
Fig. 10. Failure modes of strengthened beams for a) C:21 b) C:36 c) C:48 d) C:68.

The strengthened beams in all series failed due to the debonding of the CFRP sheet near the support region (Fig. 12a) except for beam B2 which failed due to fiber ruptured located at the beam midspan (Fig. 12c). This failure was sudden and generated loud noise due to the

rapid release of energy that was hold by the composite. During the test, more cracks were spotted in compare with the cracks that formed in the control beam which were less and wider. That indicates, the CFRP composite helped to distribute the load throughout the entire tension surface with better usage of the composite as an external flexural reinforcement as well as arresting of the cracks that formed in the tension zone from widen and propagation.

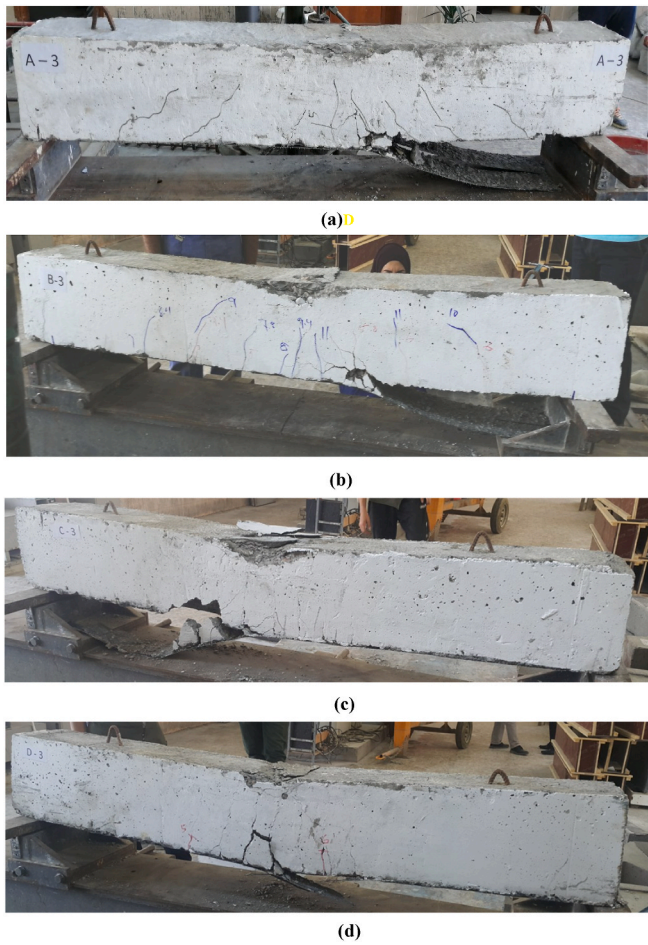
Fig. 11. Failure modes of repaired beams for a) C:21 b) C:36 c) C:48 d) C:68.

Three different mode of failure was observed in the repaired beams.

Delamination of the CFRP sheet with a thin layer of concrete cover was occurred in beam A3 (Fig. 12b), which is because of the low value of concrete compressive strength ( $f_c = 21.1$  MPa). While CFRP sheet was

debonded without separating any of concrete cover near supports observed in beams B3 and C3 (Fig. 12a) which both had higher concrete compressive strength than beam A2. Beam D3 failed due to rupture of the fiber near the beam mid-span zone (Fig. 12c). Even though the failure mode of beam D3 which constructed with the highest concrete compressive strength ( $f'_c = 68.5$  MPa) was due to fiber rupture, the improvement in the ultimate capacity was nearly as the value of beam C3 as shown in Fig. 8b. Therefore, the saturation point of concrete compressive strength for repaired beams in the current study could be  $f'_c$

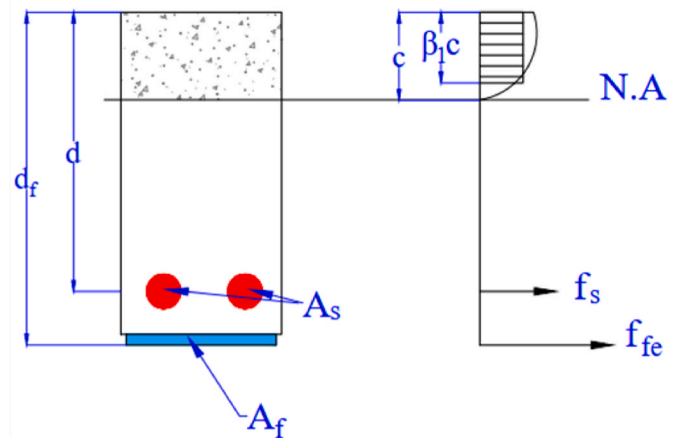
Fig. 13. Stress distribution over the section depth.

In this section, the process of estimating the ultimate moment capacity for strengthened beams is presented and discussed. The ACI 440.2R-17 code provision guidance [44] was followed for the estimation. The nominal flexural strength is calculated based on the following equation according to Fig. 13:

$$M_n = A_s f_s \left( d - \frac{\beta_1 c}{2} \right) + A_f f_{fe} \left( d_f - \frac{\beta_1 c}{2} \right) \quad (1)$$

Where  $M_n$  is the nominal flexural strength (N.mm),  $A_s$  is the area of steel reinforcement ( $\text{mm}^2$ ),  $f_s$  is the stress in steel reinforcement (MPa),  $d$  is the distance from extreme compression fiber to centroid of tension reinforcement (mm),  $c$  is the distance from extreme compression fiber to the neutral axis (mm),  $A_f$  is the area of FRP external reinforcement

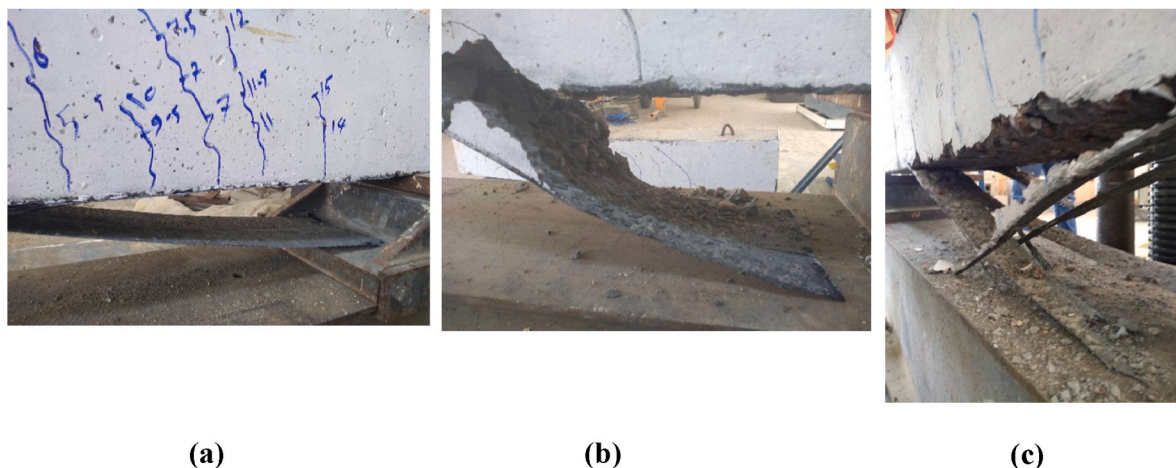
Fig. 12. Closer shoot for different mode of failure a) debonding b) cover delamination c) fiber rupture.

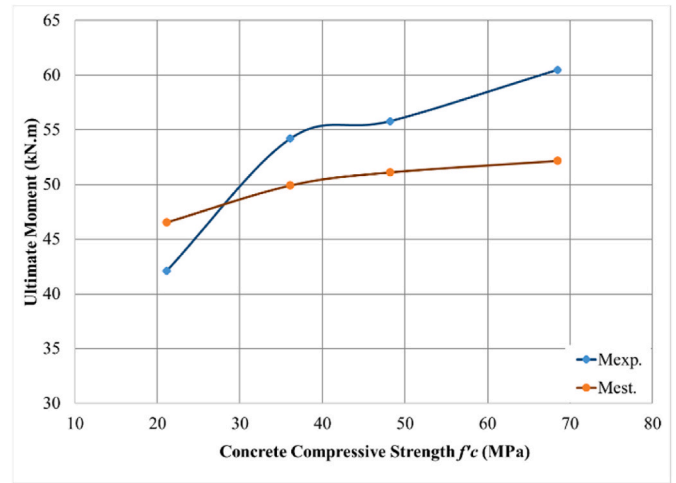
Fig. 14. Comparison between the experimental and estimated bending capacity with the varying of the concrete compressive strength.

Where  $f'_c$  is the concrete compressive strength (MPa) and  $b$  is the beam width (mm). The estimated value of the ultimate moment capacity ( $M_{est.}$ ) of strengthened beams which was calculated based on the ACI 440.2R-17 [38], (Equation (1)), is compared to the experimental value ( $M_{exp.}$ ). The estimated and experimental values are summarized in Table 9 and depicted in Fig. 14. The values of  $M_{est.}$  are in reasonable agreement with those of  $M_{exp.}$ , within  $\pm 16\%$ . In spite of the failure mode was governed by debonding of the majority of the strengthened beams (i.e., A2, C2 and D2) without reaching to the full capacity of the CFRP composite system, the estimation was acceptable in compare with the experimental results. The estimated value was higher than the experimental value for the beam with low concrete compressive strength ( $f'_c = 21.1$  MPa, Beam A2) while for beams with higher concrete strength, the divergence in the results has increased significantly with underestimating the value of ultimate moment capacity with up to (16%) for beam D2.

In addition to above explanation, it is notable that as the concrete compressive strength ( $f'_c$ ) increased up to (225%) in compare with the lower value of concrete strength ( $f'_c = 21.1$  MPa), the increase in the bending moment capacity was only (12%) from the estimated calculations based on Equation (1). Whereas the experimental evidence showed a significant improvement in the ultimate moment capacity up to (44%) with an increase in the concrete compressive strength up to (225%). Based on the above results and according to ACI 440.2R-17 provision, the varying of concrete compressive strength may not be significantly have an impact on the ultimate moment capacity. It can be clearly concluded that the ACI 440.2R-17 approach is appropriate for

estimating the ultimate moment capacity for strengthened beams with variation of concrete compressive strength between 30 and 70 MPa. However, more investigations are needed with wider range of values for the concrete compressive strength to support these findings.
