# Assessment of structural behavior of reinforced concrete slab ceiling under full load test in a residential complex project

**Abstract.** This research deals with the process of conducting a reinforced concrete slab loading test of a Residential Complex Project at the Shatt Al Arab District which is located in southern Iraq. The purpose of the test which represents a destructive test is to evaluate the structural behavior of the slab condition state during and after the examination of the test process in order to ascertain the ability of the slab ceiling to withstand the loads generated during the use of the building. The test was carried out according to ACI 437.2-13 code. The reason for this test is the postponed 8 years of building project construction. Concrete blocks were used to simulate and conduct a loading test of 30-tons for 3 days. The central point has been installed to measure the slab deflection that occurred during the test. The results showed that both the total deflection and residual deflections were lesser than the permissible values according to the ACI 437.2-13, the RC slab behavior was mainly linear structural behavior, and that the purpose of the examinati

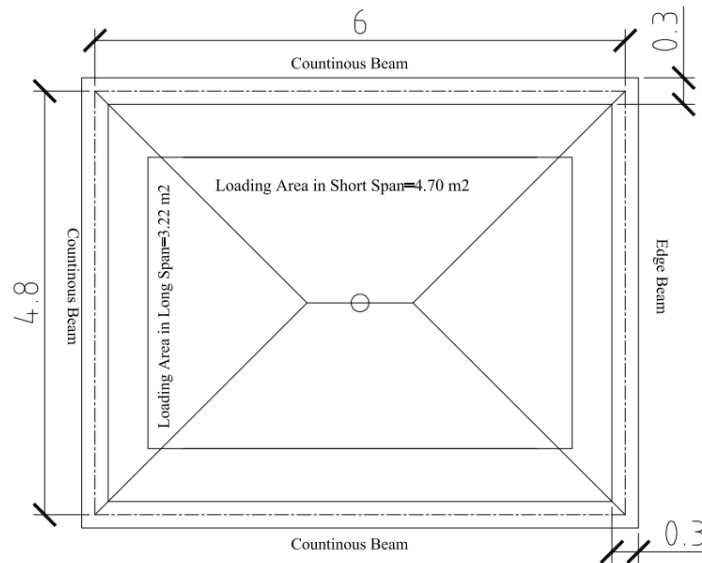
Fig. 3 Block load distribution for half portion in long and short direction of slab orientation

is ( $6 \times 2.4 \times 1.1 = 15.84 \text{ m}^2$ ) meaning that the patch area ratio is ( $15.84/28.80 = 0.55$ ) which is located at and near the center line of roof area so that this arrangement will give a higher structural response (deflection and internal stresses) leading to the results of loading test using concrete block is more safe than the uniformly distributed load on the entire area of the roof when using the same value of LTM.

One of the important and indirect results of the loading test is to know the status of the slab fixity ends condition in the short direction because it represents the critical case in the load partition, considering that both ends are continuous and casting with beams because the project was left for non-short period of time. To achieve this goal, the proposed method is presented here to determine the support condition, which depends on the degree of fixity coefficient (DOF) that is introduced here as the second parameter used in the assessment of the end slab condition. It works by comparing the test results in the middle of the short direction with the results for the free and fixed slab states to determine the degree of restriction at the ends and on the following transformation based on the unit width of the short span knowing that the slab thickness is 200 mm and concrete compressive cylinder strength is 28 MPa and from Fig. 3 which leads to;

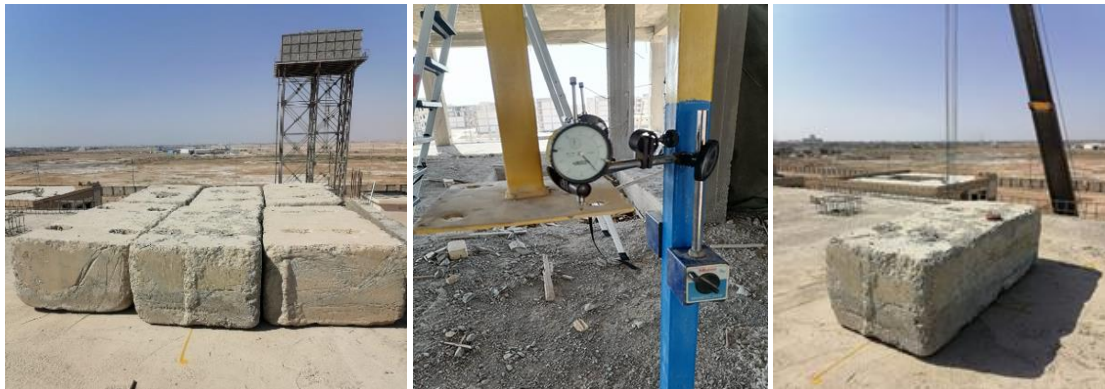
Fig. 4 Pictures show the main aspects of loading test

To demonstrate the main important aspects of the loading test such as the equipment used in lifting the concrete block, the dial gauges used to measure the deflection, and the distribution of concrete blocks in the final stage of the loading test, Fig. 4 displays the related pictures for this purpose.

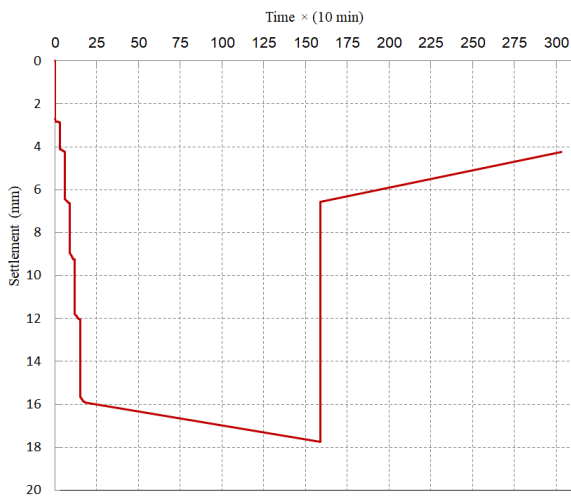
Fig. 6 Relationship between the time and the settlement for the tested roof

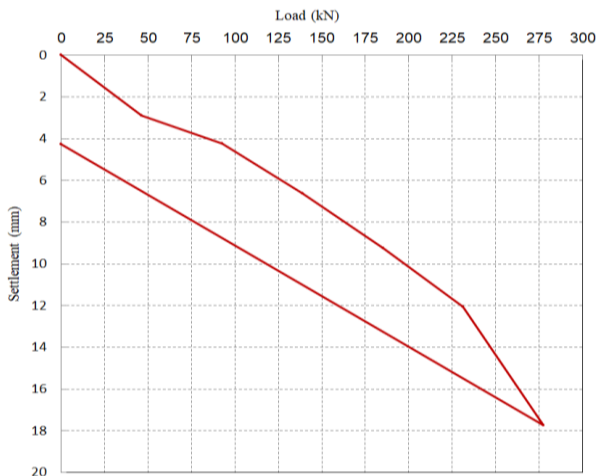
Fig. 7 Relationship between the applied load and the settlement for the tested roof

From (Fig. 7), it is so clear that the ceiling exhibits three different cases; the first where the ceiling shows a lower stiffness than all other two stages and the reason for this can be traced back to the fact that there are some defects that occurred over time (about 4 years) and among these defects a percentage of wear from creep, as well as the impact of environmental conditions on the condition of the structural roof.

The second case of loading shows a similar structural behavior, and here it can be considered the linear behavior of the RC slab roof after exceeding the old defects in the roof, and this linear stage gives us an important indication that the roof is in the normal service loads condition will behave in a linear manner as a result of the expected loads.

The last stage of the loading has a decrease in the stiffness parameter which is an important indicator of the occurrence of the nonlinear cracking condition, i.e. the completion of the linear behavior stage and the beginning of the nonlinear stage due to the occurrence of micro-cracks in the concrete roof slab in which this fact can be deduced and comprehend from the residual deflection which represents the permanent deflection (plasticity effect in RC slab)
