# Experimental investigation of mechanical behaviour and load-bearing capacity of fibreglass and metal-reinforced polypropylene sanitary manhole covers

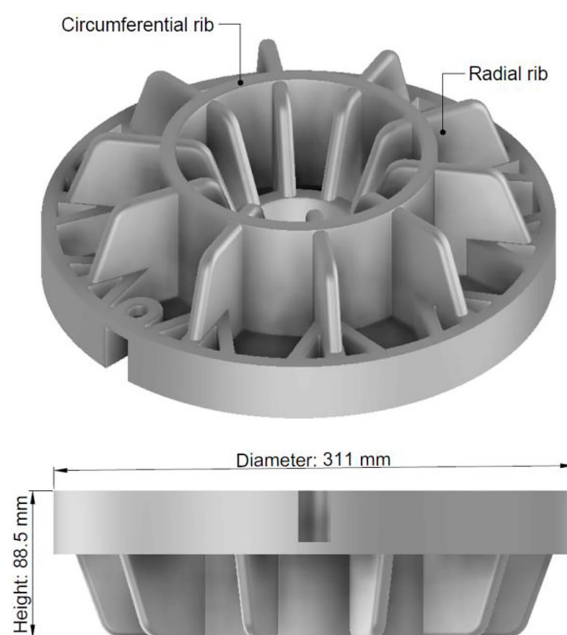
**Figure 1.** Main primary design and dimensions of the sewage chamber cover (Sample I)

The study focused on the load-bearing capacity tests on three different models of sanitary manhole covers. The first model was made entirely of polypropylene; the second was reinforced with radial ribs made of polypropylene with a certain percentage of glass fibres, and the third was made of polypropylene strengthened with a spiral steel rod which considered as circumferential ribs. The basic model was manufactured entirely from polypropylene. Figure 1 indicates the basic dimensions and the approved design. It should be noted that the other details are not authorized to be published

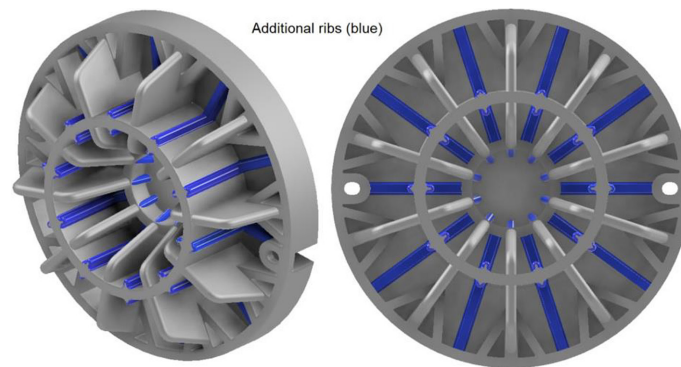
**Figure 2.** Additional radial ribs (blue) from polypropylene and glass fibres (Sample II)

In an attempt to increase the load-bearing capacity of the cover, the manhole cover geometry was modified by adding radial ribs, which are marked in blue in Figure. 2. The modified cover was manufactured from polypropylene (base material) with a filler in the form of chopped glass fibres. Two different fibre contents were used, i.e., 15 wt.% and 30 wt.%. The new mixture of polypropylene and glass fibres produced the additional radial ribs. The plastic manufacturer's data justifies using such materials with fillers, stating that polypropylene with filler in the discussed form has a higher strength than pure polypropylene, which can be up to 130%.

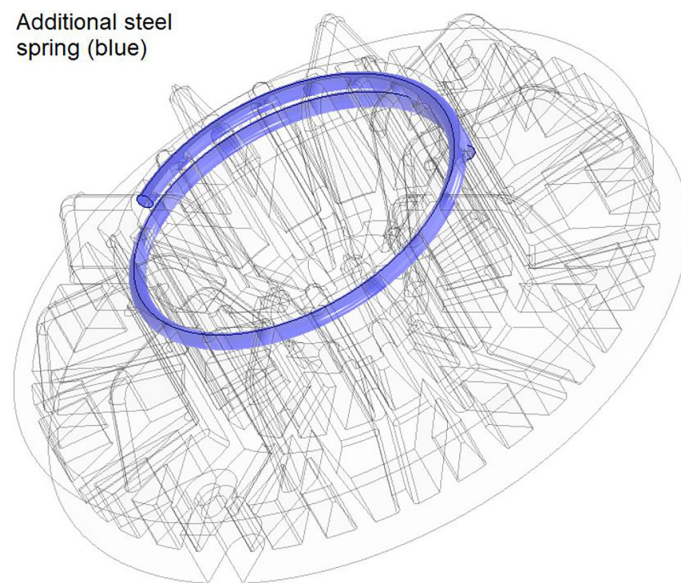
**Figure 3.** Additional circumferential ribs of spiral steel rod ((blue) (Sample III)

The last modification of the cover is done using a spiral steel rod, which is considered as additional circumferential ribs, as shown in blue in Figure 3. The modification involved injecting a steel rod spiral with a diameter of 8 mm into the lower part of the peripheral rib. A spiral with a pitch of 16 mm and 1.4 turns was used. The justification for using such structural reinforcement was the observations made at the stage of preliminary tests, which showed cracking around the circumference of the rib at a load significantly lower than the required load capacity. According to operational requirements, the cover in question must carry a load of 120 kN applied by a steel punch

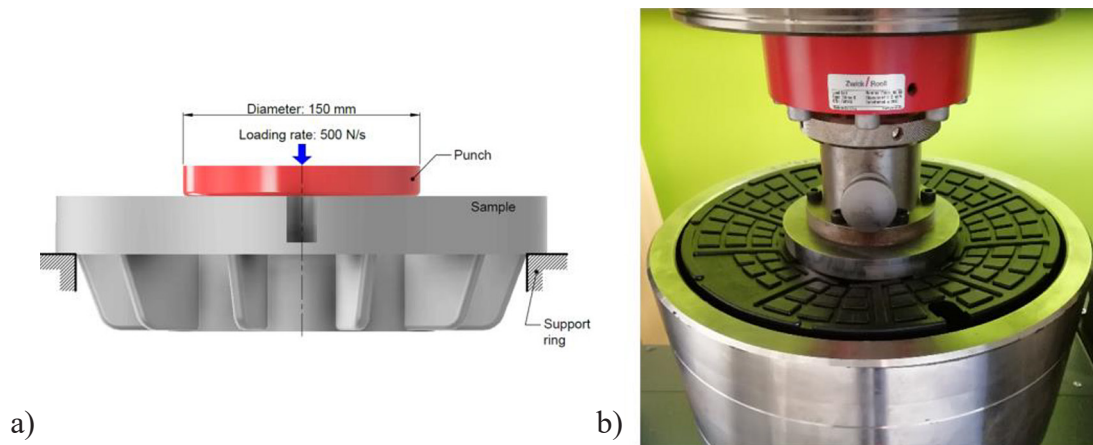
**Figure 4.** Capacity loading test (a) loading values on manhole cover and (b) actual view

with dimensions shown in Figure 4. ZwickRoell Xforce load cells (ZwickRoell, Borken, Germany) were used to measure the load capacity of the specimens. These load cells are ideal for tensile, compression and bending tests and are unaffected by parasitic changes, such as temperature variations, torque, or trans-verse forces.

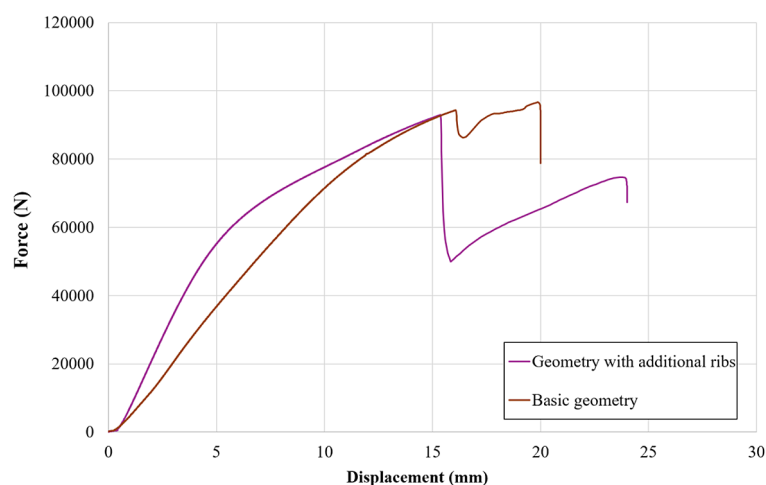
**Figure 5.** Effect of additional ribs on manhole cover compared with traditional cover according to force-displacement curves

between the variant with the primary cover model (pure polypropylene) and the cover reinforced with as additional radial glass fibre ribs. The average loading capacity of the manhole covers was determined by conducting compression tests on three specimens for each case. The results were averaged to provide a representative value for the loading capacity. Moreover, the standard deviation (SD) was calculated to quantify the variability among the specimens and ensure the reliability of the measurements. Using the SD approach ensured character analysis of the load-bearing capacity for the tested covers. The average load-bearing capacity for the primary cover model was 96.62 kN (SD=0.57 kN). In contrast, contrary to expectations, the load-bearing capacity decreased to an average value of 91.82 kN (SD=0.82 kN) in the case of additional reinforcement with glass fibre ribs. Figure 5 shows representative

force-displacement curves for the considered variants; based on them, it can be concluded that additional ribs significantly increase the stiffness of the cover. This steeper slope indicates increased stiffness, reflecting a more excellent resistance to deformation under the applied load. Although the ultimate load-bearing capacity slightly decreased, the improved stiffness of the rib-reinforced covers enhances their ability to maintain shape under operational loads, as supported by similar findings in the literature [21–22]. The hypothetical cause of the reduction in load capacity is the stress concentration phenomenon, which could have occurred in the connection of additional radial ribs with the circumferential rib [23–24].

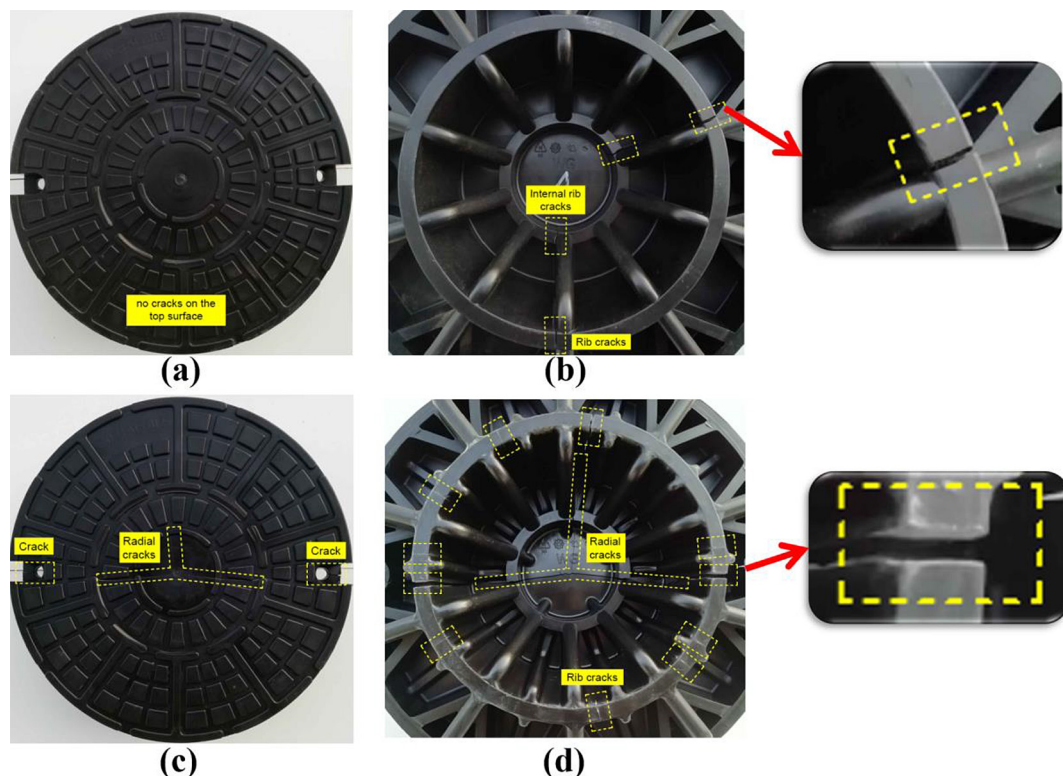
**Figure 6.** Influence of glass fibre reinforcement on the load-bearing capacity of the cover  
(a) front side without reinforcement, (b) back side without reinforcement, (c) front side with reinforcement, and (d) back side with reinforcement

For a more detailed analysis, a basic visual test was examined for the manhole cover with and without glass fibre reinforcement (Figure 6). The visual test of the covers involved a thorough inspection to identify any surface defects,

cracks, or deformations that occurred during or after the load-bearing tests. The inspection focused on areas of high stress, particularly near the reinforced ribs and steel spiral rod, where damage was most likely to initiate. This evaluation assessed the structural integrity and quality of the covers, ensuring that any potential failure modes or weaknesses were documented. Figures 6a and b show the front and back of the cover without any glass fibre reinforcement. The cover appears more positively under loading because the front is free of visible defects (Figure 6a) and has a few internal rib cracks on the back (Figure 6b). The analysis of the cover variant with additional reinforcing ribs revealed cracks spreading radially in three directions from the centre of the cover on its upper surface (Figure 6c). The view of the underside confirmed that the central part of the cover suffered radial cracks throughout the thickness of the material (Figure 6d). Notably, these cracks

occurred with a smaller displacement of the load-causing punch than in destroying the cover with basic geometry. Consequently, the circumferential rib of this version transferred the load through deformation, thereby preventing the main surface of the cover from cracking. However, introducing additional ribs stiffened the circumferential rib, significantly reducing the possibility of its deformation due to stretching along the circumference. This, in turn, prevented the cover surface from cracking due to excessive stiffness. The circumferential rib in the variant with additional stiffening was caused by the accumulation of stresses caused by the additional ribs. Such cracks occurred in eleven locations. In several cases, a crack was observed directly next to the additional ribs on both sides.

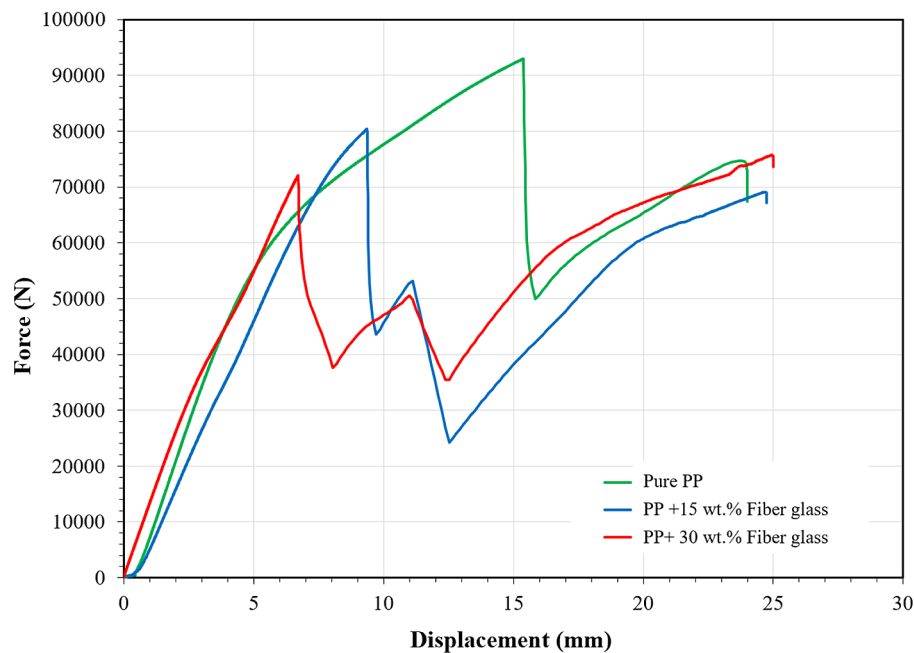
**Figure 7.** The force-displacement curves for pure PP, PP + 15 wt% fibre glass, and PP + 30 wt% fibre glass show the effect of the fibre glass percentage on the manhole cover compared to a pure propylene cove

In the test shown in Figure 7, typical curves were found for covers made of pure PP and covers made of PP with a filler of glass fibres that had two different amounts (15 wt.% and 30 wt.%). It was assumed that glass fibre reinforcement would

lead to higher load-bearing manhole covers. Tests, however, showed that covers made of filled plastic have a lower load-bearing capacity than the traditional version made of pure PP, which had an average load-bearing capacity of 91.82 kN. Thus, increasing the content of chopped glass fibres reduces the load-bearing capacity of the cover. Figure 7 shows the average force-displacement curves for three specimens tested in each case for pure PP, PP + 15% fibre glass, and PP + 30% fibre glass, respectively. The average value of the cover load capacity decreased by 12.36 kN when there was a 15 wt.% content of glass fibres, representing a 13.46% weakening compared to the traditional version of pure PP. In contrast, the variant with a 30 wt.% filler content shows a 19.31 kN decrease in load-bearing capacity, resulting in a 21.03% weakening compared to the pure PP cover.

The analysis of the test results indicates that in the case of the last variant considered, the dispersion of the load capacity is significant, as it amounts to 2.68 kN. For the cover made of unfilled plastic (SD: 0.82 kN) and with 15 wt.% fibre content (SD: 0.71 kN), the results were satisfactorily repeatable. This phenomenon may indicate an

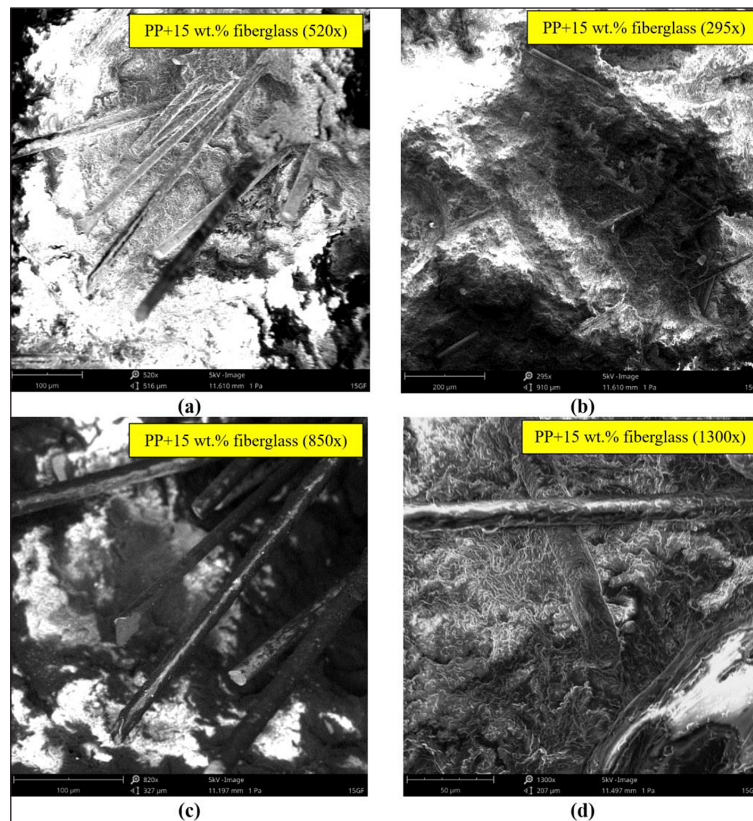
**Figure 8.** Microstructure of PP + 15 wt.% glass fibre reinforcement at different zooms (a) 520x, (b) 295x, (c) 850x, and (d) 1300x

In this study, the JEOL JSM-6610A was used as a scanning electron microscope (SEM). The SEM has a backscattered electron (BSE) detector with a 20 kV accelerating voltage and 40 nA current. In order to determine the reasons why the addition of fibres leads to a reduction in the load-bearing capacity of the cover, the crack surfaces of the peripheral rib were analysed for variants with different contents of the considered filler. Figures 8a and b show different fracture surface areas of the cover with 15 wt.% fibreglass content. Observations of the selected area reveal a non-uniform distribution of fibres in the mate-material volume, with significant fibre clusters visible (Figure 8a) and areas with negligible fibre density (Figure 8a). Therefore, uneven fibre dispersion resulting from plastic injection into a mould with multidirectional geometry may be one of the reasons for the weakening of the cover structure [25]. However, the direction of fibre arrangement, which in most cases is parallel or oblique to the crack surface, has a more significant impact on the reduction of the load-bearing capacity [26–27]. To further highlight the fibres, their structure, and potential breakage, images

were examined at higher magnifications (850x and 1300x), as shown in Figure 8c and d. In fact, no broken fibres that would be stretched during loading were observed at the fractures. The dominant direction of the fibres coincides with the direction of the material flow during the injection process, and a rib with cylindrical geometry is created as a result of the material flow in the axial direction, which determines the dominant direction of the fibres. The reinforcing fibres then provide the desired strengthening effect when subjected to stretching. At the same time, their transverse or diagonal orientation towards the direction of the load mainly causes the polypropylene material to be torn off from the surface of the fibres, and the fibres are torn off and not stretched. The adhesion between glass fibres and polypropylene has significantly lower strength than the polypropylene material, hence the weakening of the structure of the reinforced material.

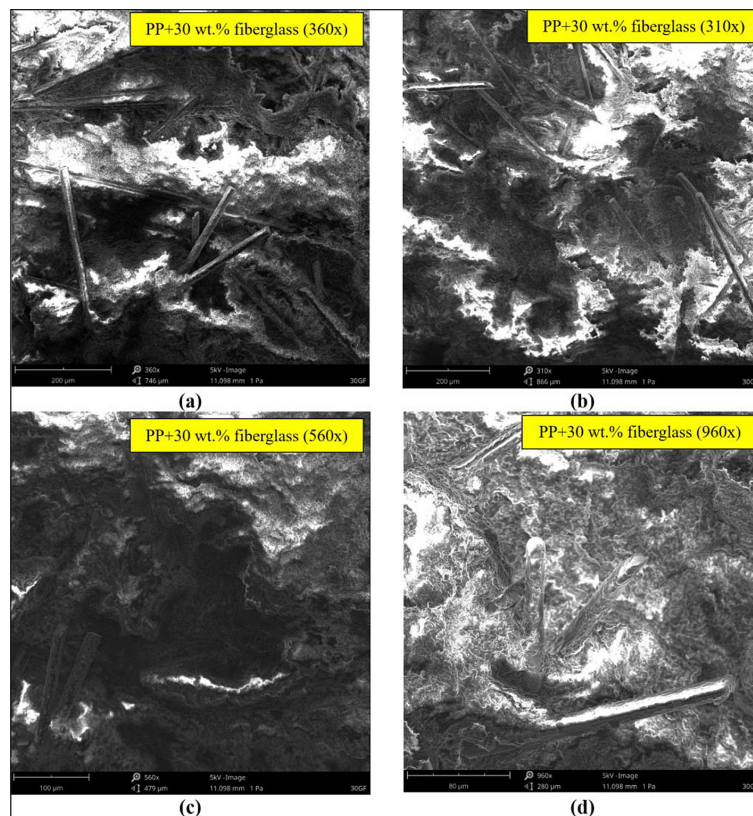
**Figure 9.** Microstructure of PP + 40 wt.% glass fibre reinforcement at different zooms (a) 360x, (b) 310x, (c) 560x, and (d) 960x

Similar phenomena, i.e., uneven fibre dispersion and the dominant, parallel direction of fibre alignment, were observed for the variant with 30 wt.% glass fibre content (Figures 9 a and b). The demonstrated decrease in the load-bearing capacity of the cover with an increase in the reinforcement content can be explained by the principle of proportionality. If there are statistically twice as many relatively weak fibre-polypropylene adhesive connections in the material structure, then the load-bearing capacity is proportionally lower [28].

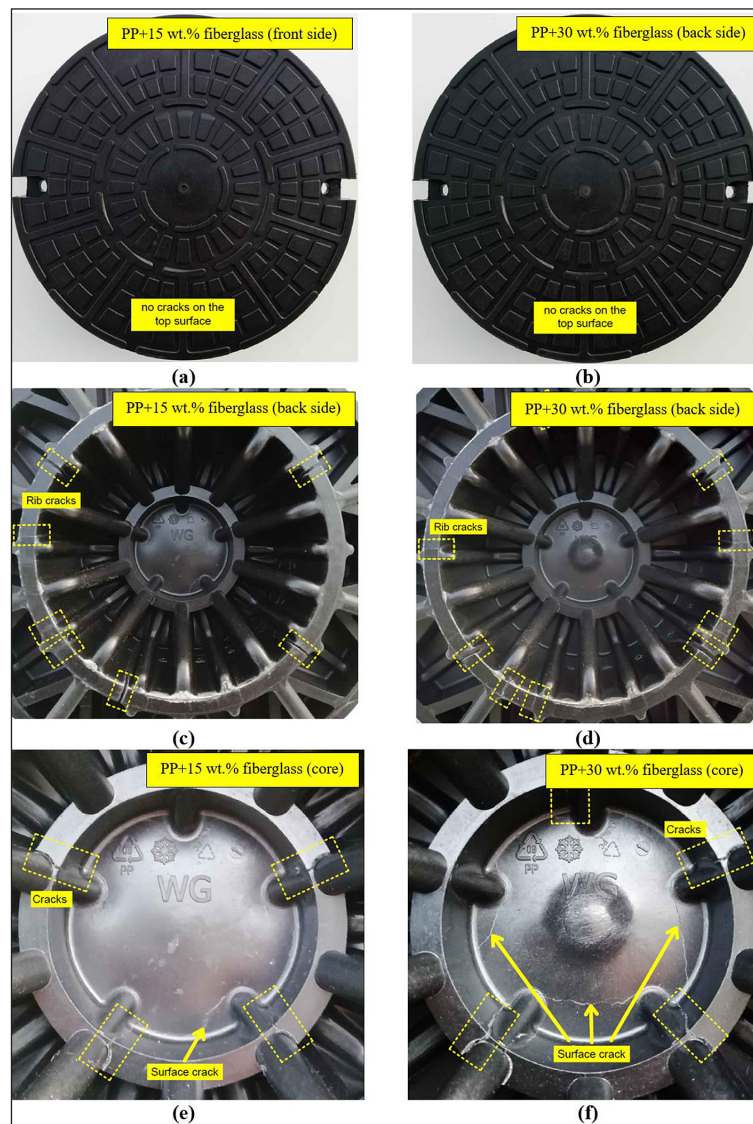
**Figure 10.** Crack's locations (a) front side (15% wt. glass fibre), (b) front side (30% wt. glass fibre), (c) back side (15% wt. glass fibre), (d) back side (30% wt. glass fibre), (e) core (15% wt. glass fibre), and (f) core (30% wt. glass fibre)

Regarding the macroscopic analysis of cracks, it was observed that the front side manhole cover variants with filler were damaged similarly with both considered contents. Unlike the variant with the same geometry made of pure polypropylene, the covers with glass fibre reinforcement did not crack on the front surface in any of the tests, on which both in the case of the 15 wt.% glass fibre variant (Figure 10a) and the 30 wt.% (Figure 10b) showed no signs of destruction. Observations of the back side of the covers showed that the circumferential rib was cracked in several locations in the vast majority of cases with additional radial stiffening ribs (Figures 10 c and d), which, as

previously shown, is the effect of stress concentration by these additional ribs [29]. It was also shown that in the variants considered, cracking occurred in many positions of the internal circumferential rib (Figure 10 e and f) in cover core region, and surface cracks were observed in the central area of the covers. Cracking on the outer circumference of the cover is a phenomenon that only occurs in the variant with 15 wt.% fibrous reinforcement content.

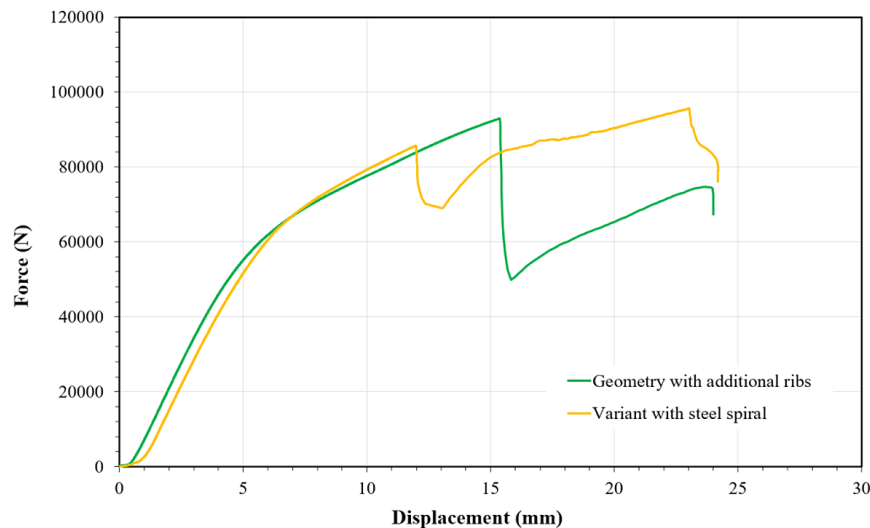
**Figure 11.** Effect of steel radial ribs on manhole cover compared with fibre glass reinforced cover according to force-displacement curves

Figure 11 provides a summary of the curves obtained during compression tests of various cover variants, including those with additional radial ribs and those with the same geometry but an

additional spiral steel bar. The covers functioned similarly during the initial loading phase, showing no significant differences in stiffness. However, during the tests for the variants with a spiral, the phenomenon of tearing was observed in the plastic area surrounding the steel rod, which means that the interaction between the steel reinforcement and the surrounding plastic material plays a significant role in the overall load-bearing capacity. The result was a significant reduction in the cross-sectional area of the circumferential rib, leading to cracking with an average force value of 86.21 kN (SD = 1.06 kN). This was lower than the load capacity of the variant without a bar, which was 91.82 kN (SD = 0.82 kN). However,

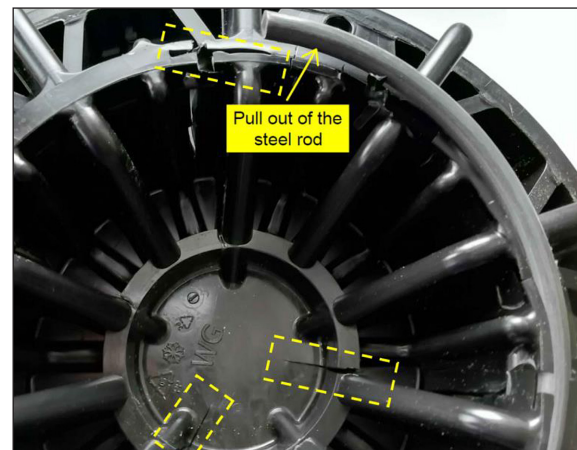
**Figure 12.** Crack locations in the case of adding a steel radial rib

unlike the second variant, with a further increase in the cover deformation, the force increased to a higher value, i.e., an average of 97.35 (SD = 3.6 kN). It indicates that the rod is located too close to the lower surface of the edge; the negligible adhesion forces between the steel rod and the polypropylene material with sufficient deformation result in the tearing of the rod with significantly greater stiffness than the material, as shown in Figure 12.

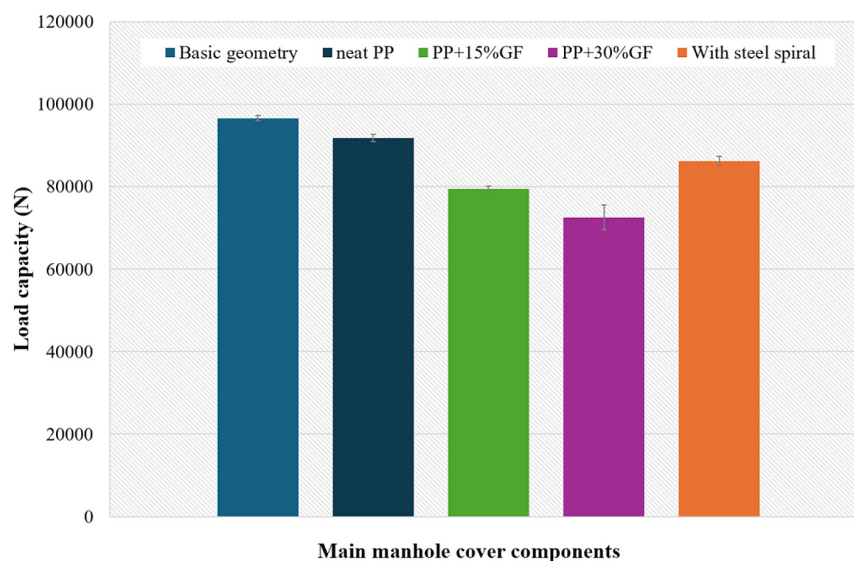
**Figure 13.** Effect of main manhole cover components on the load capacity
