Research Article

Influence of Concrete Compressive Strength on CFRP Strengthening and Repairing of RC Two-Way Slabs

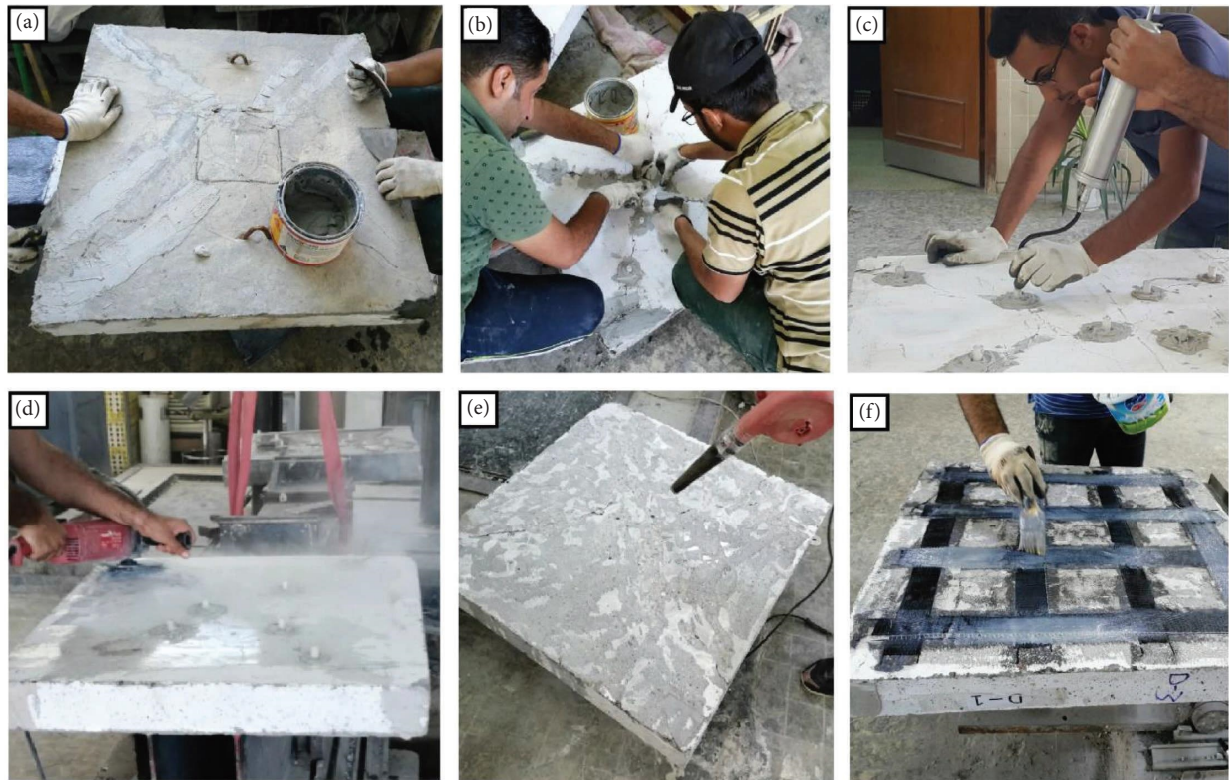
For the repairing process, all the tenuous damaged parts and the cracks that took place on the top face (i.e., the compression side) of the control slabs during the test were sealed by adding Sikadur31 (epoxy paste adhesive). On the other hand, a new technique of repairing severely damaged parts and the wide cracks in the tension side is introduced. A repair material named Sikadur-52 LP was injected by using surface packers. To use this technique, all deep cracks in the tension zone surface were cleaned from any loose particles, dirt, and dust by using an air blower. Holes were made on the concrete tension surface exactly on the cracks track to install

surface packers which were situated at an approximate distance of 15 cm between each other. Then, the repair material (Sikadur-52 LP) was injected inside the cracks through surface packers. After a week, all surface packers were removed, followed by flattening the surface by using a grinder, and then the same procedure that had been done before with the strengthened slabs was followed. All the previous description of the repair process is shown in Figure 5. The manufacturer's properties as mentioned in the product datasheet of Sikadur-31 and Sikadur-52 LP at 7 days are given in Table 6.

FIGURE 5: Repair process of control slabs after testing: (a) sealing the cracks on the compression side with Sikadur-31 material, (b) making holes and installing surface parkers on the tension side, (c) injecting Sikadur-52 LP material, (d) flattening the surface, (e) surface cleaning, and (f) applying the CFRP composite system.

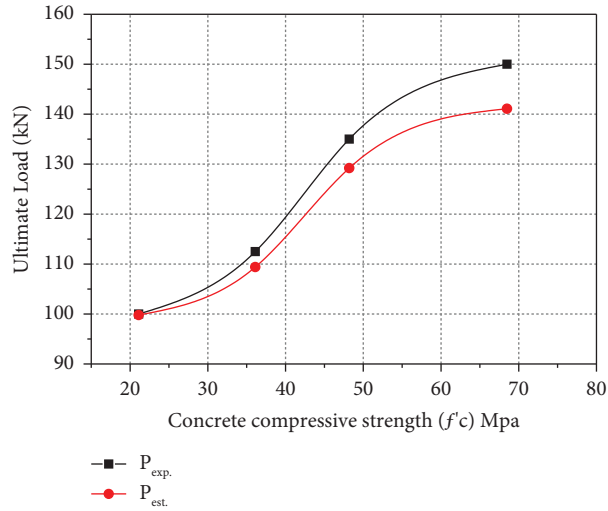
The analytical evaluation of control and strengthened slabs are listed in Table 8 and plotted in Figures 13 and 14, respectively. The maximum load capacity of control slabs was estimated by using equation (1), while equation (6) was implemented for the strengthened slabs.

FIGURE 13: Comparison between the experimental and estimated maximum load capacity with the varying of the concrete compressive strength for control slabs.

The method demonstrated good concordance with experimental data, achieving a margin of error under 10%, as shown in Table 7. Therefore, it is possible to use theoretical equations to estimate the ultimate load for control slabs and reinforced slabs.

It is notable that as the concrete compressive strength (f'_c) increased, the divergence in the results between the estimated and experimental increased. This approach may not be accurate for high strength concrete. Therefore, more experimental investigations are required for slabs with compressive strength higher than 70 MPa.
